Department of Mechanical Engineering

THESIS

DOCTORATE (LMD)

NUMERICAL AND EXPERIMENTAL STUDY OF ELLIPTICAL CRACKS IN THE CRITICAL POSITIONS OF PIPELINE

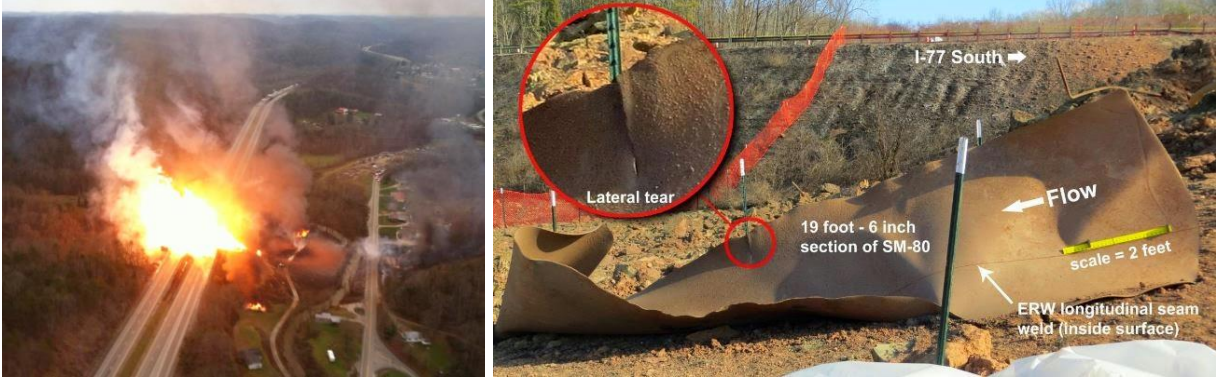
Figure I.3: Incident in Columbian gas transmission natural gas pipeline [13]

In 2012, pipeline of Colombian gas transmission was failed due the degradation of wall thickness by external corrosion (see figure I.3). The pressure increase and operator error were the main causes of this accident. Furthermore, it was not checked during last 24 years of incident event [13]. According to the investigations, the pipeline also had not the shutoff valves which could prevent the catastrophic damage. This accident left a lot of damages such as;

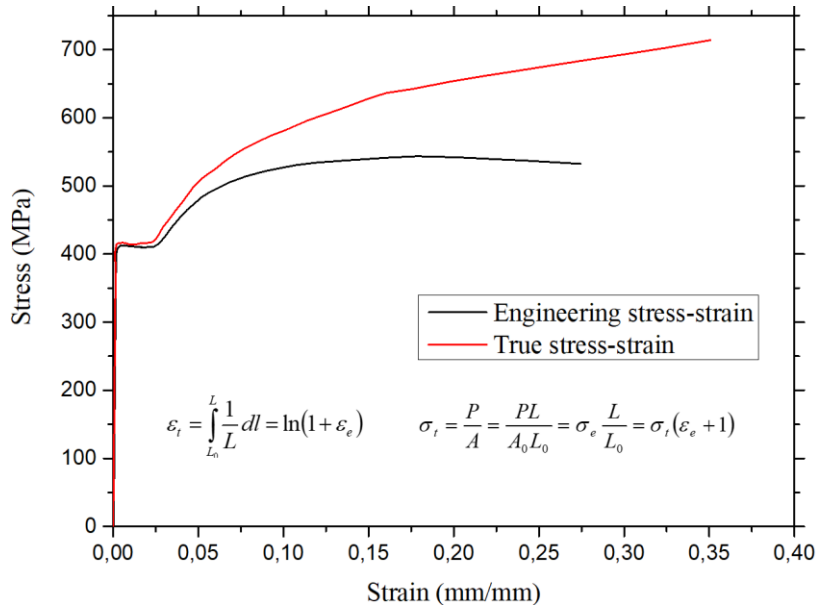
Figure II.1. Engineering and true stress-strain curves of API 5L X52 pipeline steel [2].

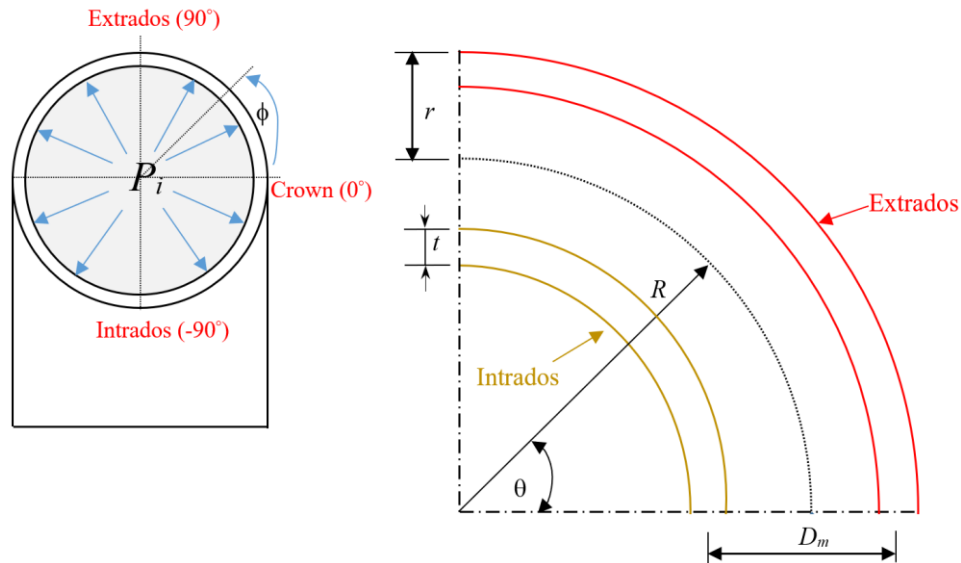
Figure II.3: Geometrical model of a 90° pipe elbow subjected to internal pressure.

The behavior analysis of elbow during flow shows that the intrados area is subjected to the highest hoop stress, while the extrados zone has the lowest hoop stress as illustrated in equation II.9 [10]. In addition, the increasing of bend radius leads to increase the hoop stress at the extrados area, but it decreases at the intrados area [11].

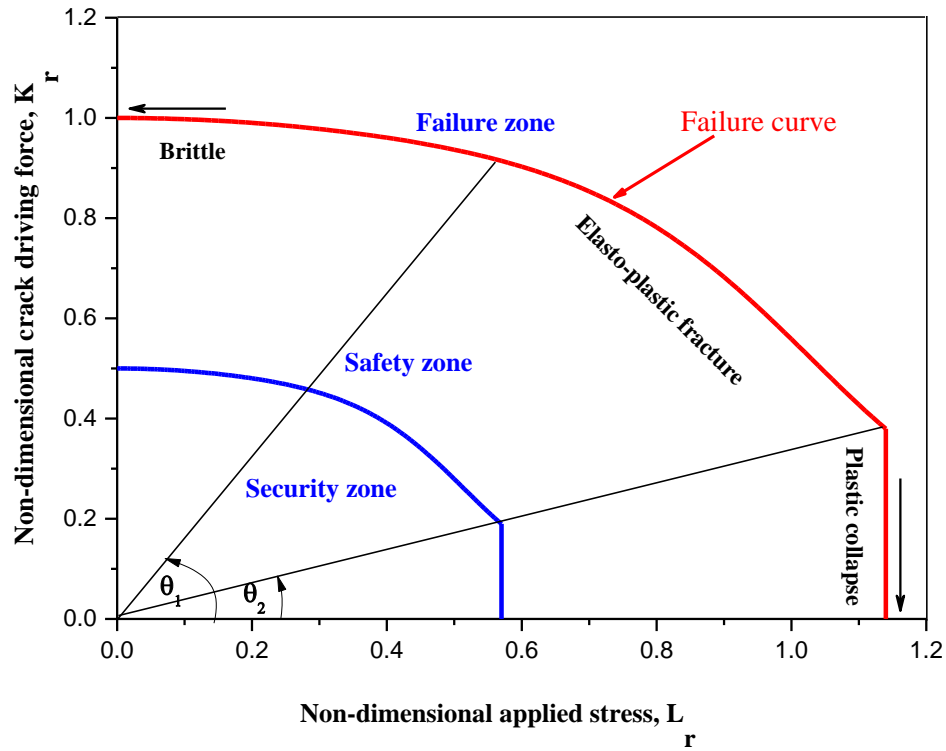
Figure II.8: Schematic view of the Failure Assessment Diagram (FAD) and three typical domains.

indicates critical condition, the structure is safe. If the assessment point is above the curve, failure occurs [49].

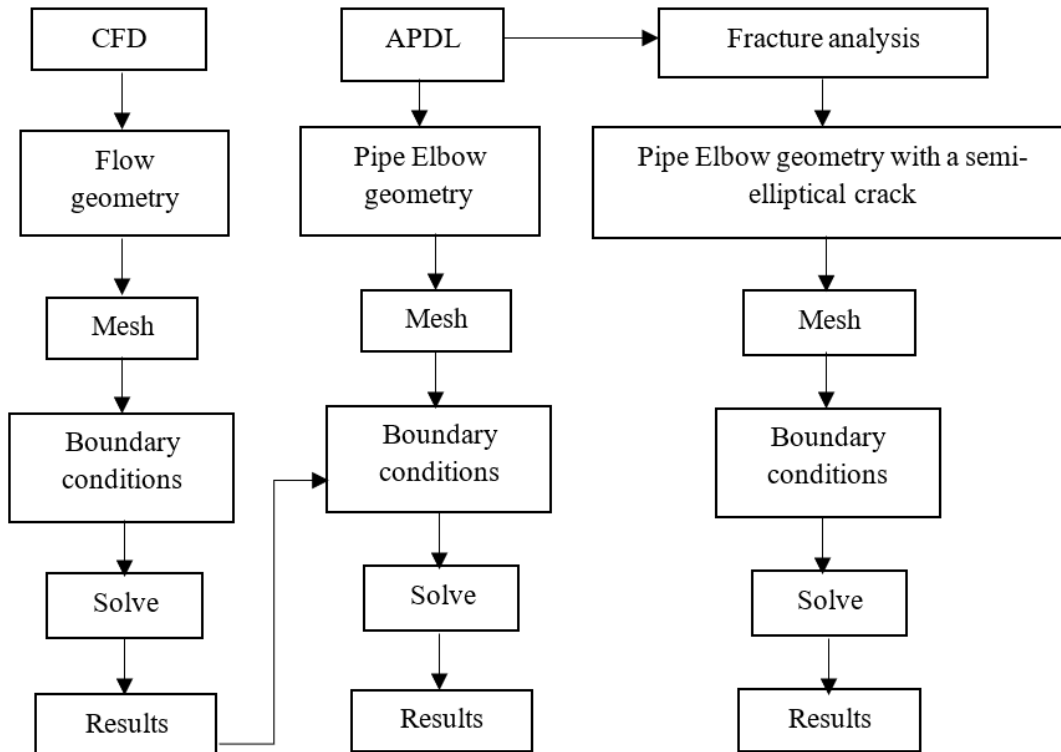
Figure III.2: Schematic description for numerical methodology.

natural gas. In fact, we have used the FVM of computational fluid dynamics (CFD) to study the behavior of gas flow and pressure distributions along pipe elbow. These pressures across the elbow were obtained by the importation of the other section called APDL (Ansys Parametric Design Language) using FEM. The figure III.2 illustrates the methodology of numerical steps. First of all, elbow radius was applied progressively in order to show the stress. At stabilization, the study of stress distributions along elbow curvature under gas pressure of 7 MPa was conducted in order to get the critical position defined as the position of maximum stress.

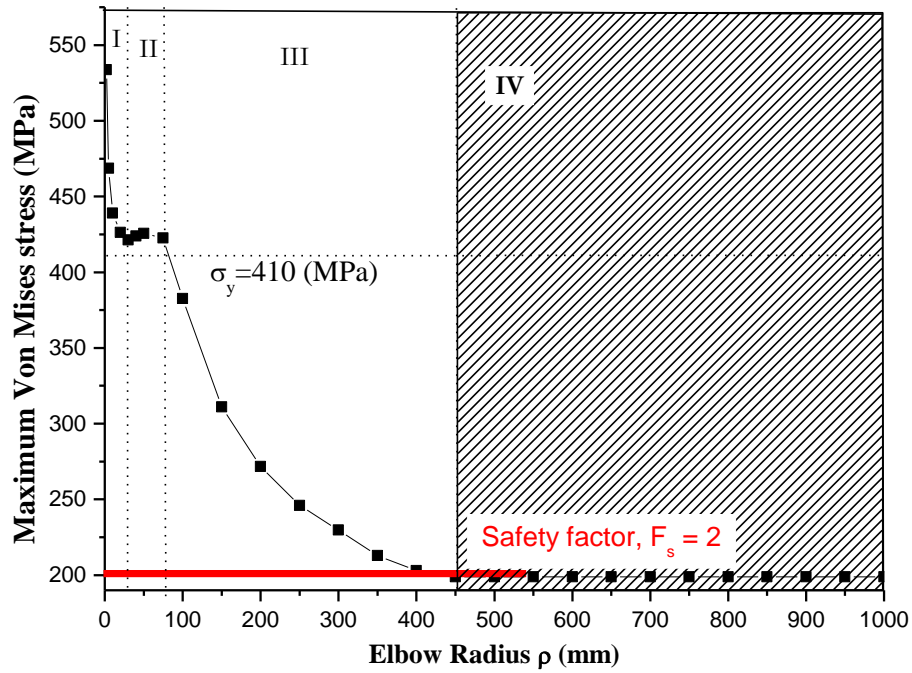
Figure III.7: Effect of elbow radius on maximum Von Mises Stress.

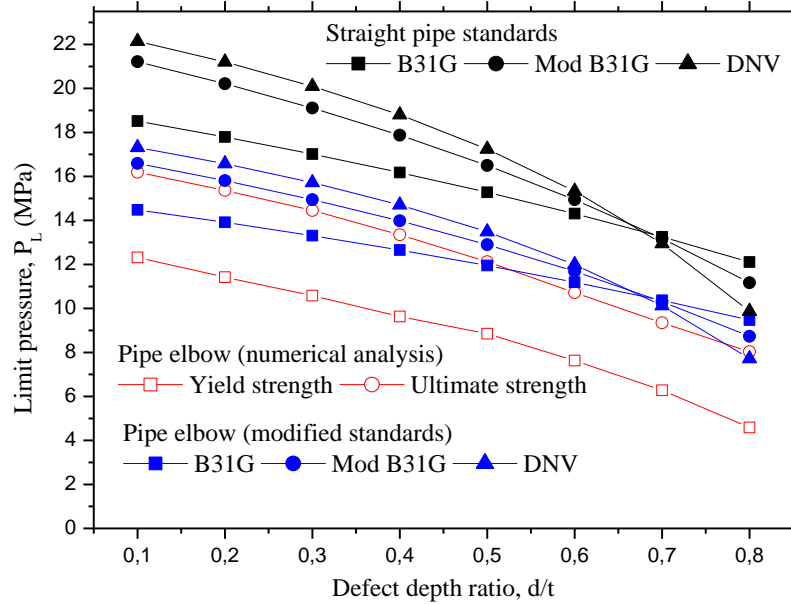
Figure III.23: Comparison between the limit pressure values in the straight pipe and the pipe elbow (at the intrados section) for different depth ratios ($d/t = 0.1 - 0.8$).

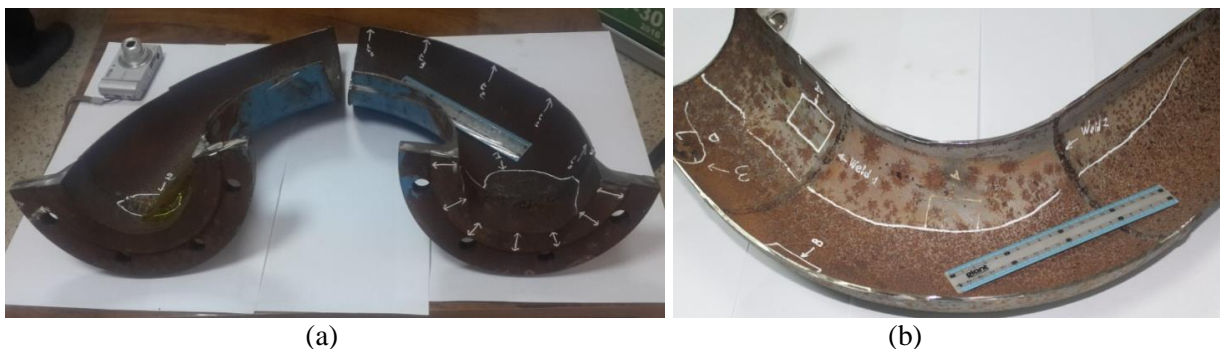
Figure IV.4: General view of the internal surface of failed pipe elbows, (a) elbow I, and (b) elbow II.

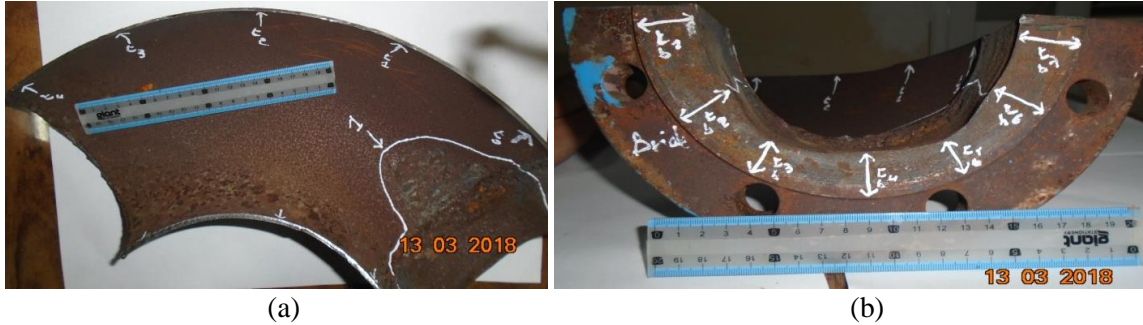
Figure IV.5: Degradation of wall thickness (a) elbow pipe (part I), and (b) flange steel.

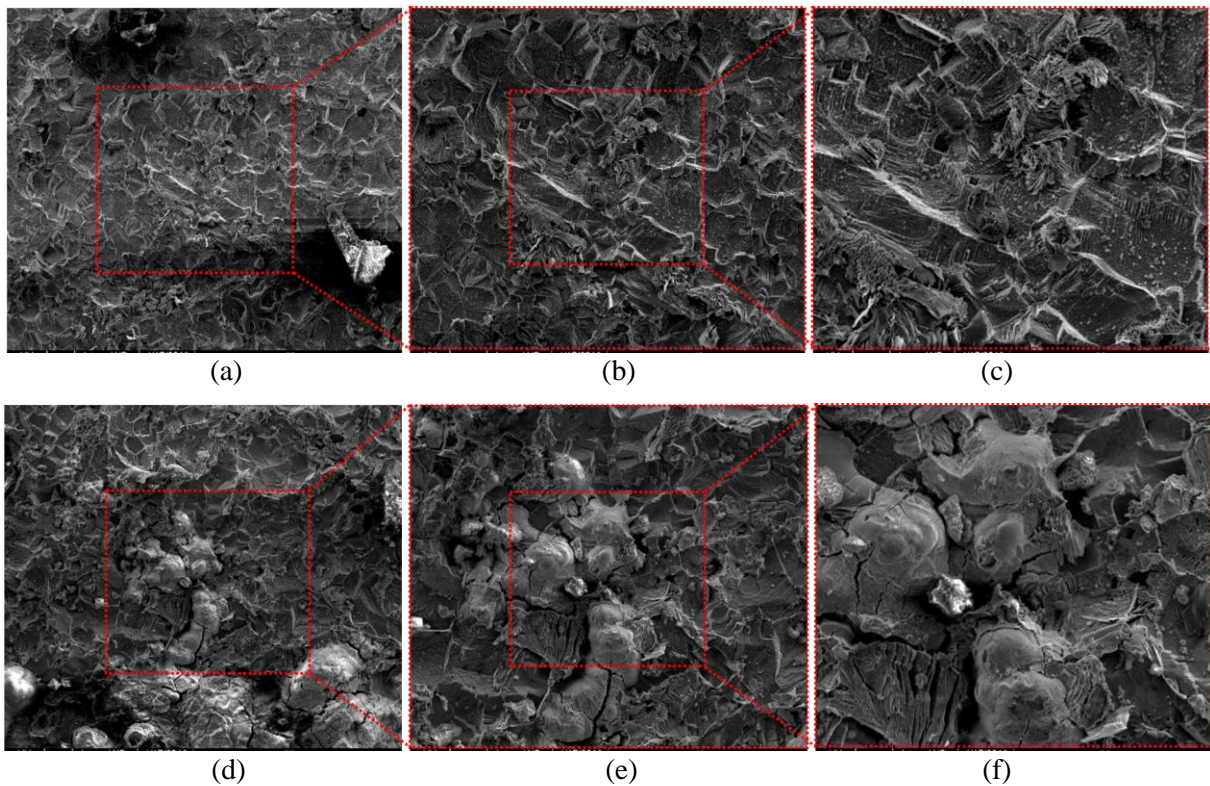
Figure IV.10: Top-surface SEM image of Region A for two positions with different sizes (a) position I with 50 μm , (b) position I with 40 μm , (c) position I with 20 μm , (d) position II with 50 μm , (e) position II with 40 μm , and (f) position II with 20 μm .
