Hassiba Benbouali University of Chlef

## DOCTORATE

**Investigate of pipelines repair by composite materials and natural fibers, considering the influence of the chemical properties of hydrocarbons on their structures**

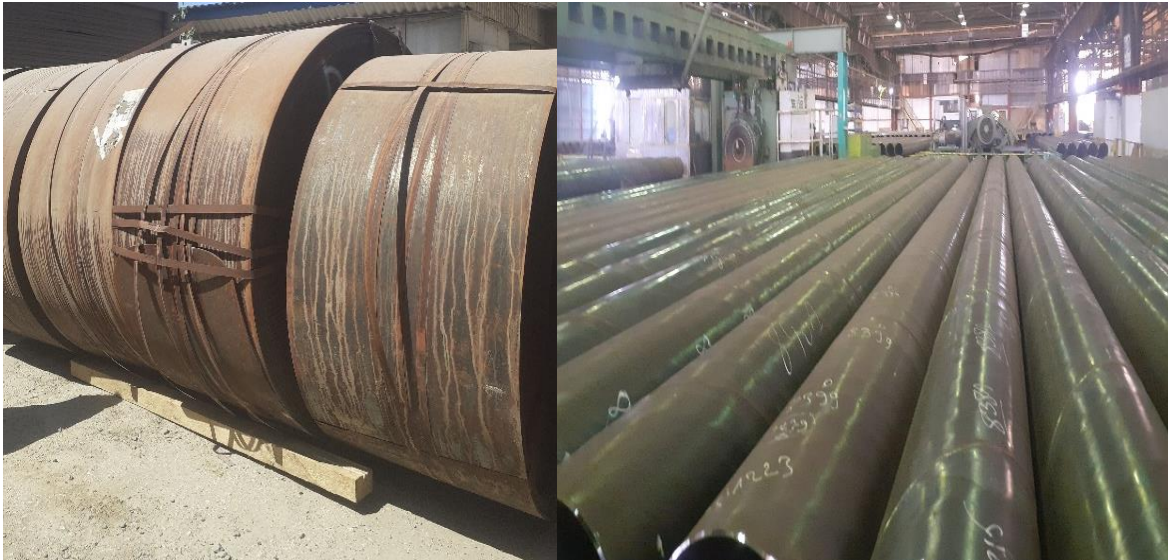
Fig.1.5  
Technique for shaping the welded pipeline into the spiral.

In the framework industry of piping systems in energy fields, most companies selected the kind of welded piping systems in a spiral form due to the recommendation of most of the oil and gas laboratories. Many manufacturers worldwide have used the welded spiral pipes that are installed in different regions by national companies, where they have been used by SONTRACH and SONEGGAZ.

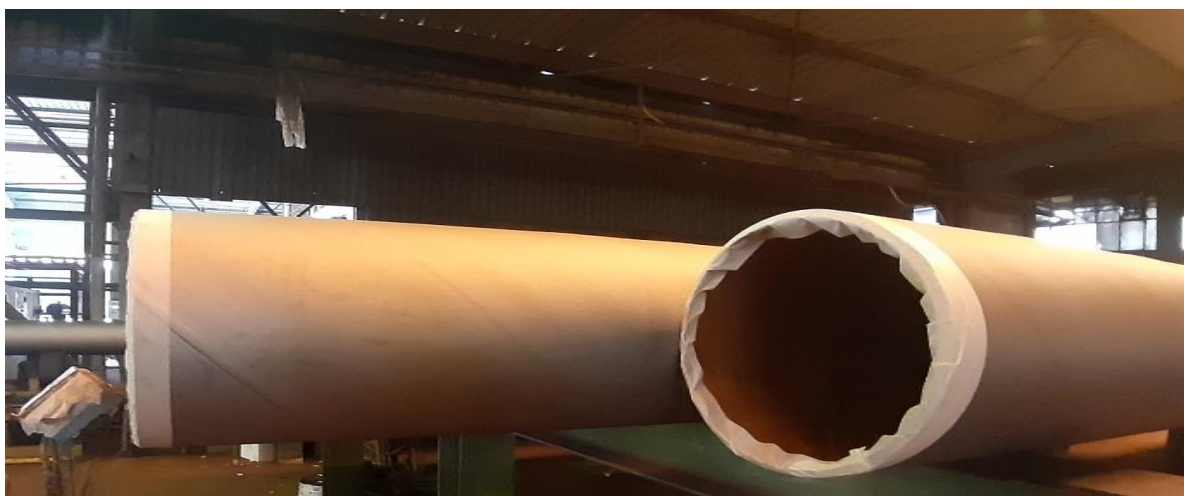
Fig.1.7 Outer pipe stripping

Stripping: Stripping the pipe after forming and control tests is carried out to eliminate oxide particles on the pipe surface as well as surface cleaning for a better coating [8].

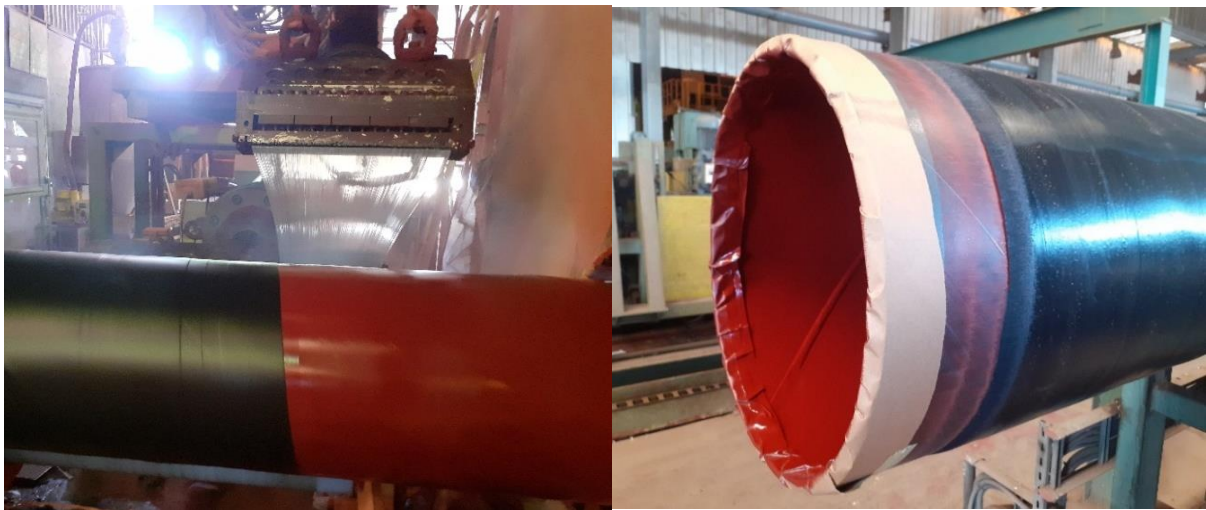
Fig.1.8 Cladding of pipes a) exterior and b) interior.

**Pipe coating:** Pipelines buried or laid on the surface sometimes emerged in fresh or salt water for this reason, the coating is made up of three layers: the first is epoxy resin applied by electrostatic spraying 50 to 80 microns thick, the second layer is a copolymer intended to ensure polyethylene adhesion, and the last layer is extruded polyethylene. The advantages of exterior polyethylene coating are characterized by excellent adhesion of coating to steel, and high resistance to soil aggressiveness is determined by analyzing the pH, chlorides and sulfate. The interior coating is made of epoxy resin meeting the requirements of the API RP 5L Standard[32].

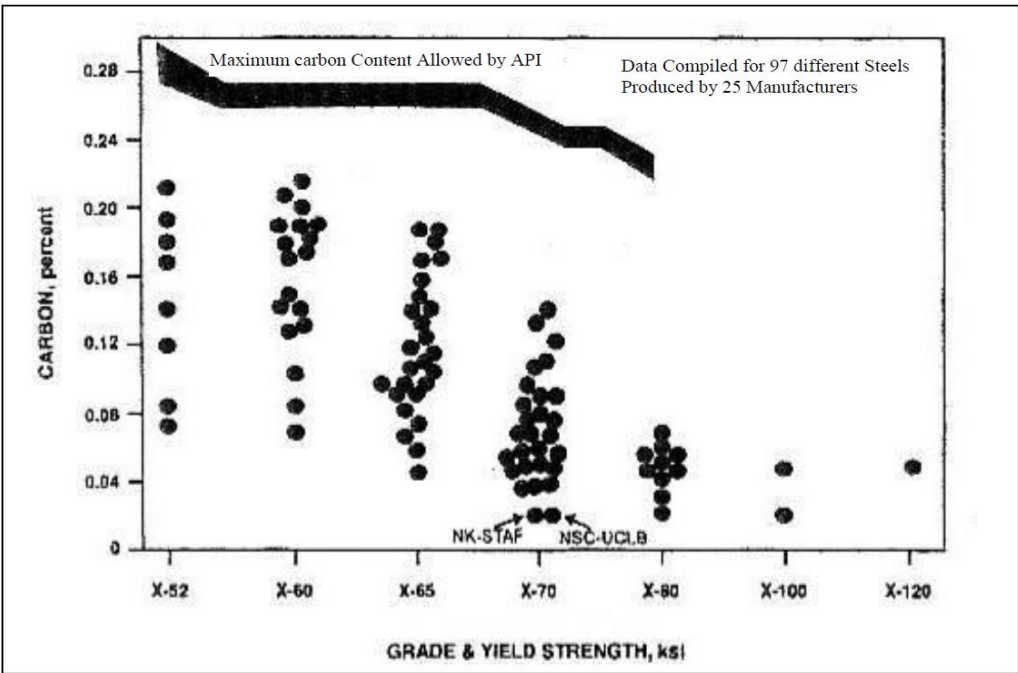
Fig.1.11The percentage of carbon depending on the grade API fromX42-X120[11, 12].

The API standards are among the norms that define the presence of carbon content to classify the grade of steel (Fig1.11) on the one hand, and on the other hand, they are many kinds of pipeline that are designed by different types including iron with carbon, iron with copper and iron with aluminum as well as it possible to use carbon fiber, natural fiber and hybrid fiber. The pipelines have been used depending on the percentage of carbons and other additives as follows X42-X52, X60, X65, and X70-X120 [10-13].

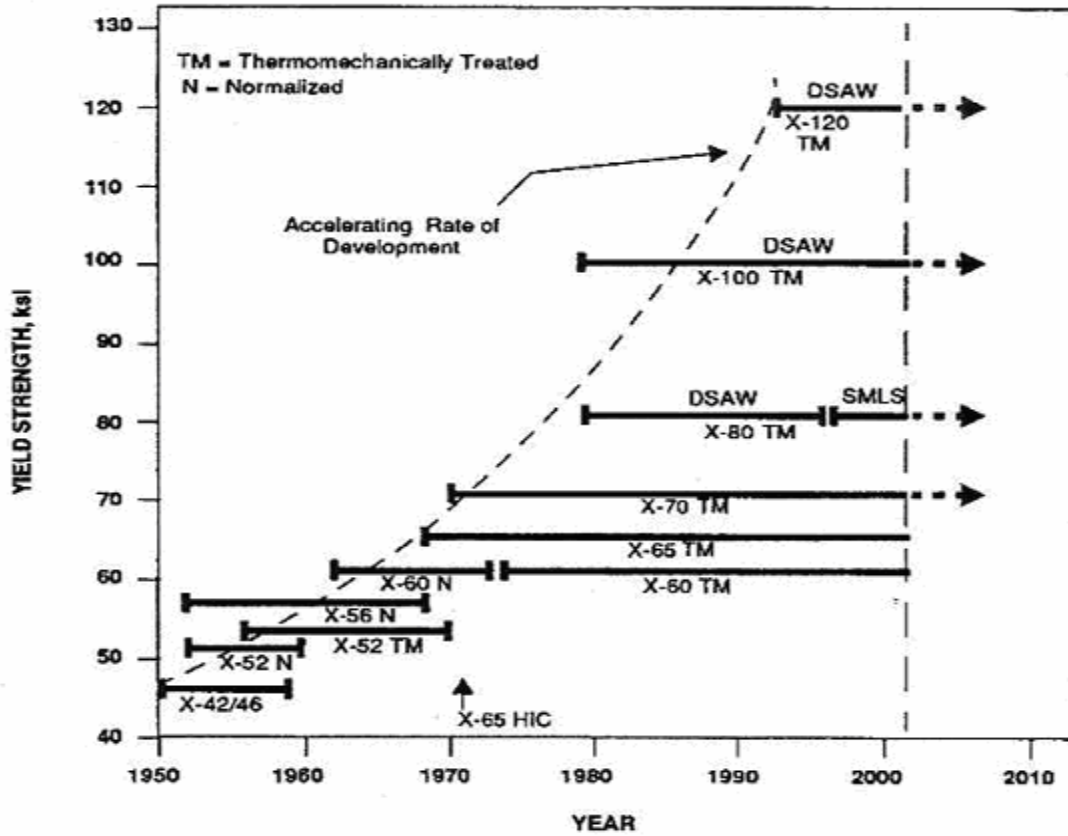
Fig.1.12 Pipeline steel grade development over time [11,19].

The accelerated cooling process (Figs. 1. 13, 14) is adopted during slab rolling in order to achieve a homogeneous, fine-grained microstructure to obtain better mechanical properties. The resistance of material (steel) reaches 700 MPa in the standard norms, taking into account the dimensions as well as the effect of the temperature. Depending on the recent studies, it has been proven that the efficiency of the structure of the complex chemical composition of the carbon fiber with the addition of Ni and Ti, is able to reach the fabrication of the pipes and gasoline pipes with a diameter of 1420 mm with a 20-inch. These pipes have excellent features such as high density to the end rupture and the limits of resistance to the rupture, as shown Fig.1.12 [17-20].

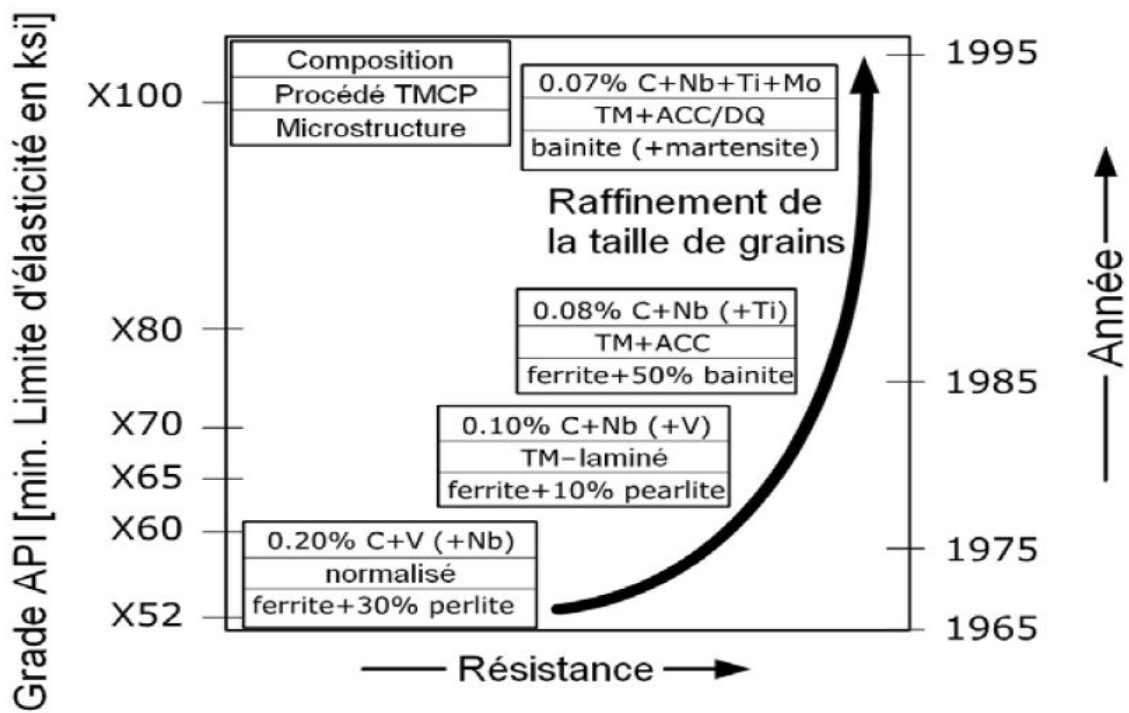
Fig.1.13 Pipeline development (composition, TMCP process, microstructure, API grade) [18,20].

In the case of low alloy steels, the final microstructure depends on the cooling rate and the final cooling temperature [13-14]. The cooling method (see Figs.1.13 and 1.14) is used while the sheet is rolling to perform homogeneously for better mechanical characteristics and excellent corrosion resistance (HIC), close to steels made by conventional thermo-mechanical lamination [21,22]. The TRC diagram (see Fig.1.14) helps full the microstructures as a model of the cooling rate.

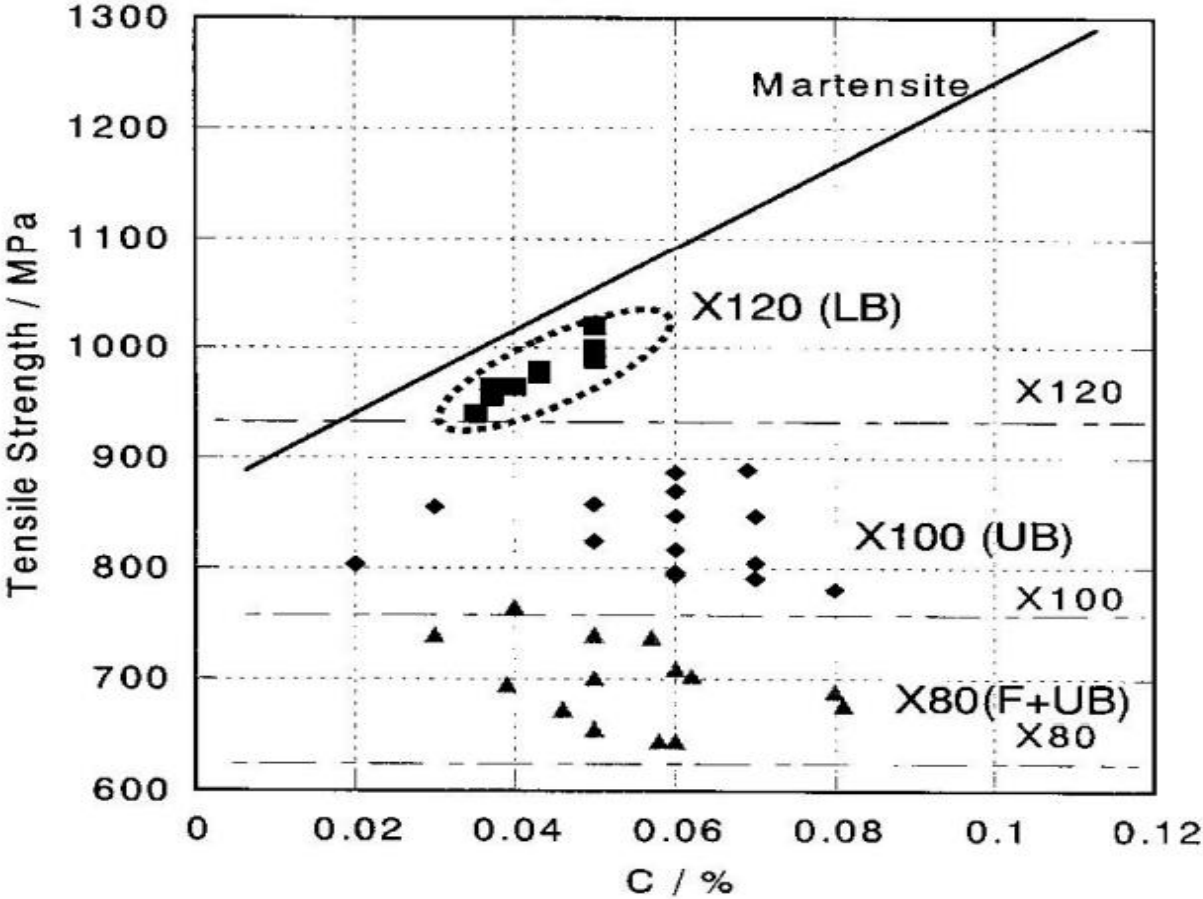
Fig.1.15 Evolution of the mechanical properties of the plates according to the grades [24].

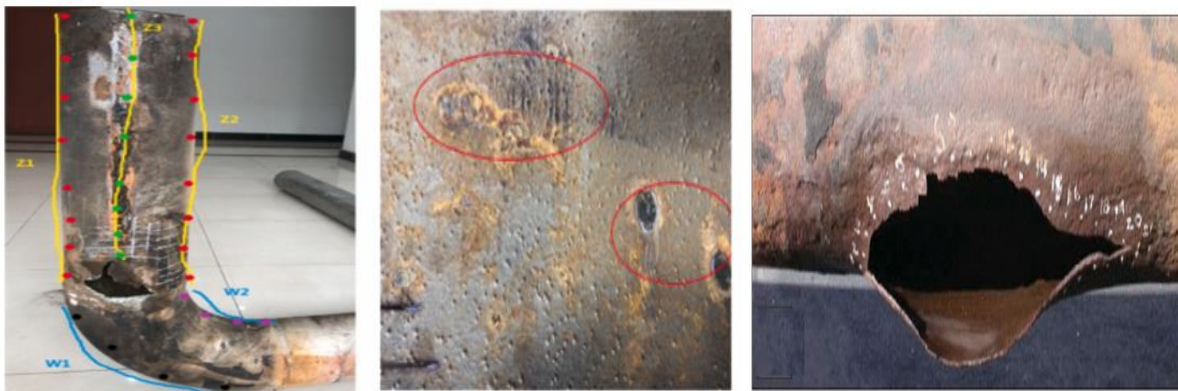
Fig.1.16 Damage of accident pipeline cause interaction steel-flow [30], a) broken pipe, b) morphology insides the rupturefluid [31] and c) fracture due to the SCC, plastic deformation - the local bulging [29].

During the transport of hydrocarbons, several cracks occurred at critical positions due to many reasons such as vibrations and load. According to the major reasons for the corrosion phenomenon, which generates through appearing small cracks at critical zones such as around welding positions, valves, and elbows to change the pipeline direction on the one hand, on the other hand, the cracks can take several forms including semi-elliptical forms with depth or superficial, There is a lower pipeline rupture pressure for the localized corrosion reaction type of defect; the rupture pressure depends on the interaction that occurs between internal hydrocarbon-steel defects and the external steel-soil environment associated with stresses of higher temperatures see (Fig 1.16 [25-29]).

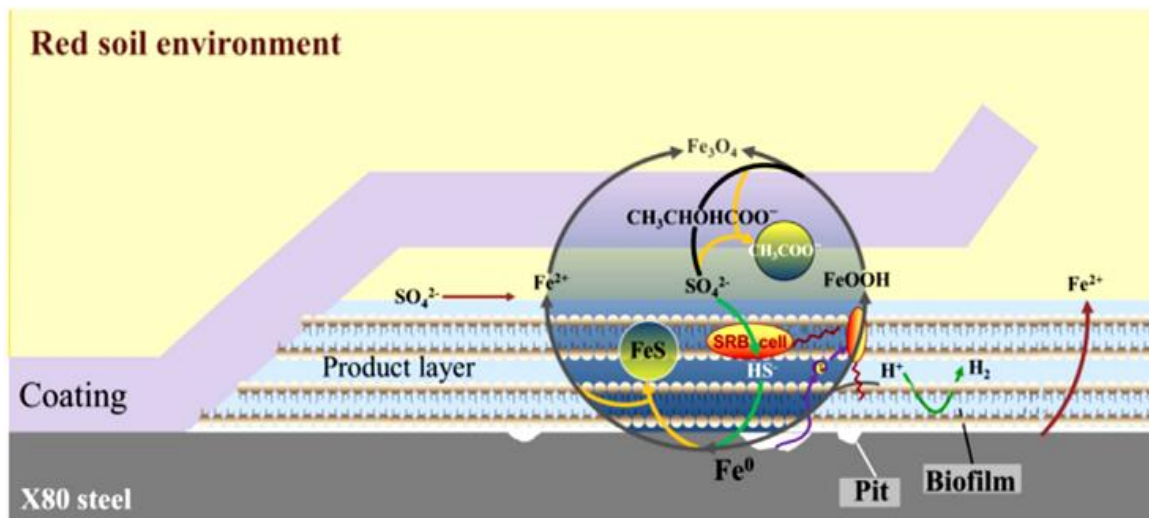
Fig.1.17 Schematic diagram illustrating the electrochemical reactions, interaction X80 steel containing red, soil environment [33].

environment (see Fig1.17 [32,33]). These conditions help to keep the safety of the piping systems from the corrosion phenomenon through humidity [30], contamination by bacteria [33], naphthanic acid corrosion [31], as well as the friction wear and cracks due to the high pressure and temperature [60].

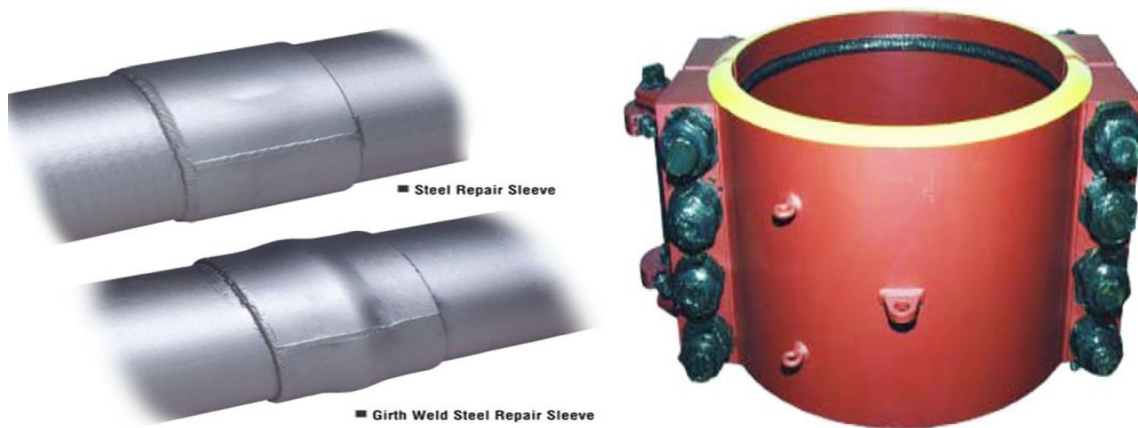
a) Steel repair sleeves [50]. b) Sleeve repair clamp [51].

c) Clock Spring repair [52].

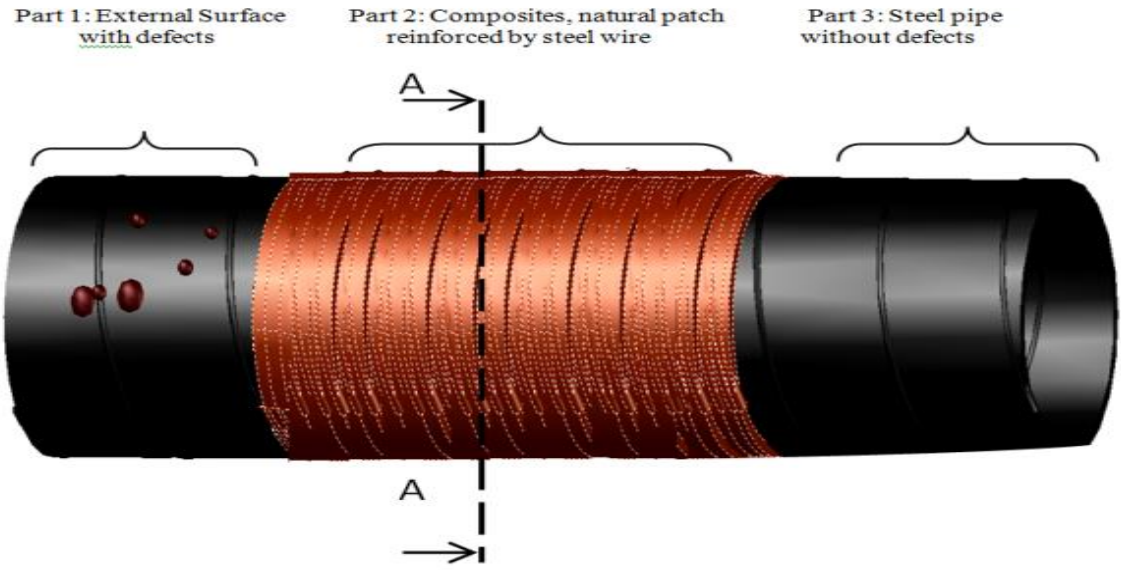
Fig.1.23The sketch corroded pipeline repaired by hybrid composites (natural fiber and synthetic fiber) [122].

In this project, Jute fibers reinforced with Steel wires, fiberglass, and polyester were used as patch to repair defects along of piping systems due to their excellent mechanical properties [71,72]. However, the natural composite became a sustainable alternative to the materials used due to the high resistance, resistance of corrosion, low costs and recyclable [100,101, 120-121].

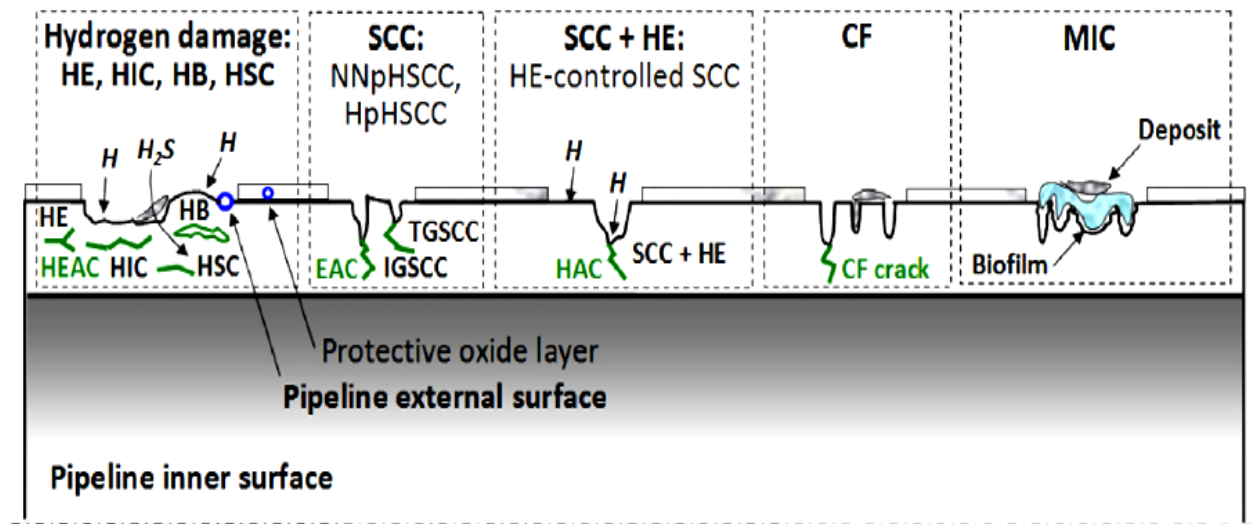
Fig.2.1 External corrosion-induced failure mechanisms of oil and gas pipelines acting on the exterior of the pipe due to corrosive soil [30].

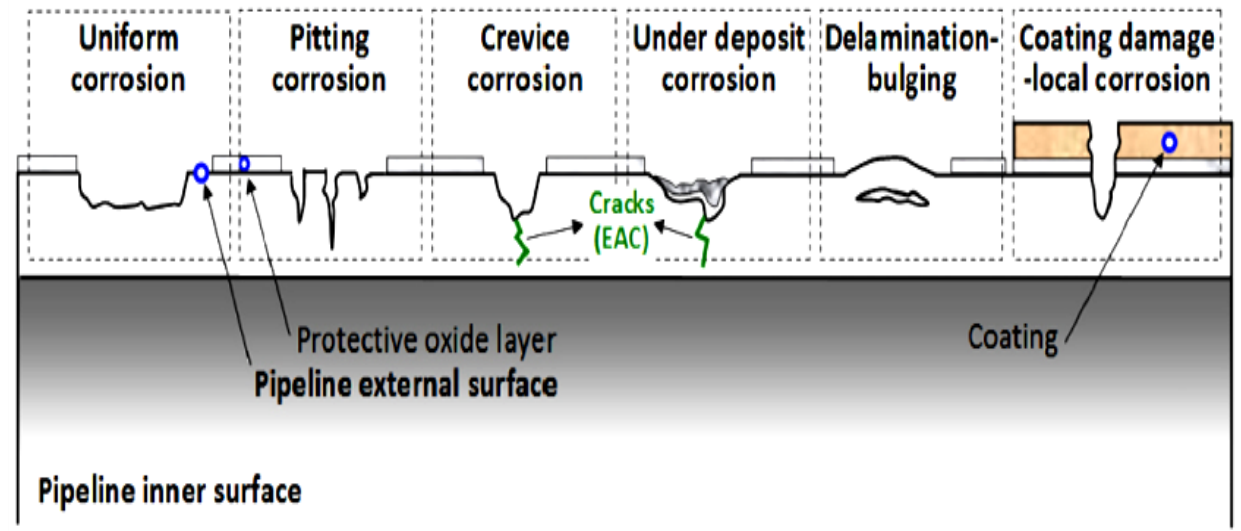
Fig.2.2 Représentation schématique en coupe transversale de toutes les formes caractéristiques présentées de corrosion externe [30].

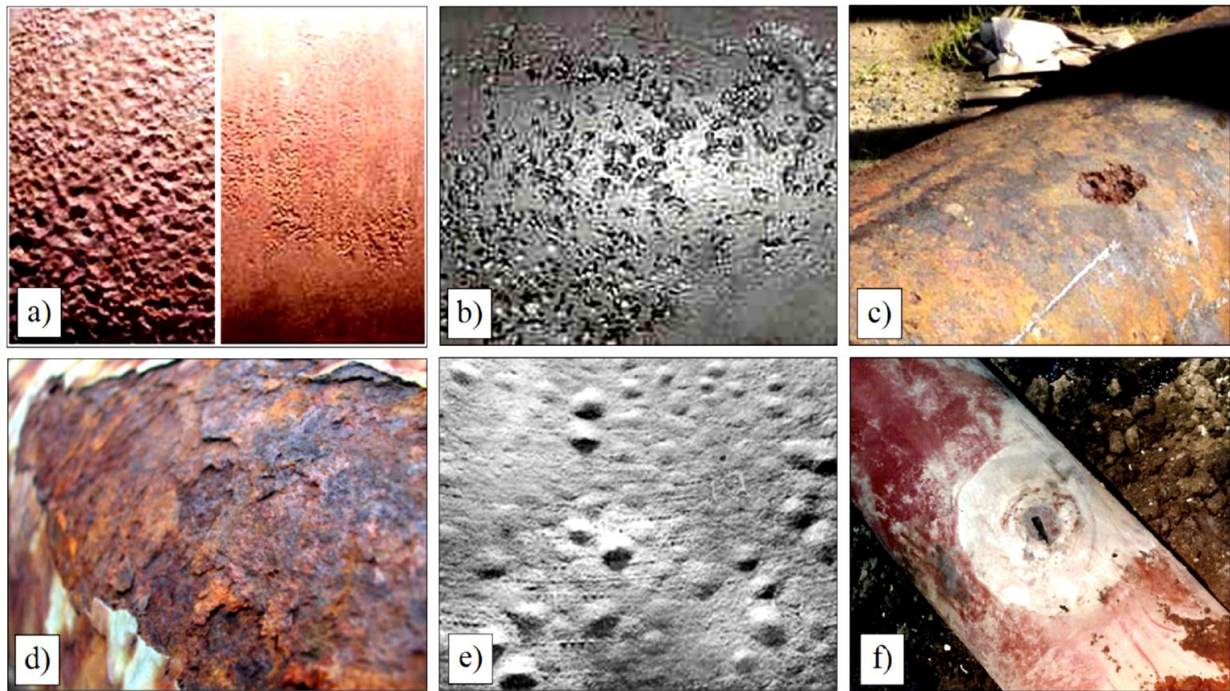
a) Uniform corrosion (Ginzel, Kanters); b) Pitting corrosion (Ginzel, Kanters); c) Crevice corrosion (Asadi and Melchers, 2017); d) Underdeposit corrosion (By Corrvie.com and Reviewed by Gopal R., 1484); e) Delamination-bulging, hydrogen blisters (Mostert, 2005). f) Coating damage - local crevice corrosion (Norsworthy, 2009).

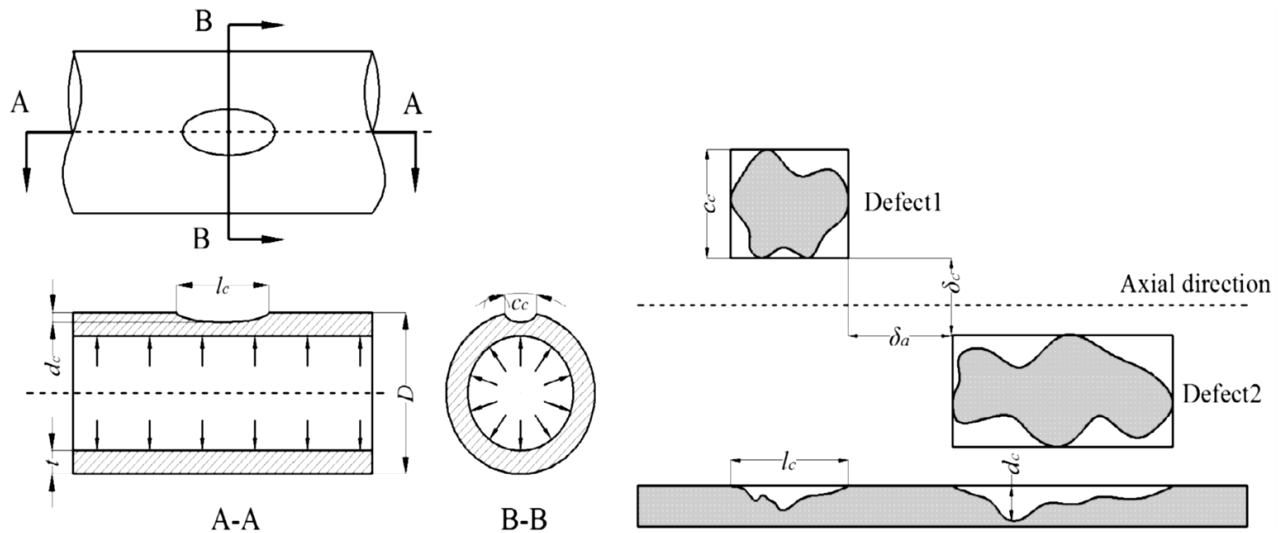
Fig.2.4 Schematic of the numerical model with corrosion defects [42].

On the other hand the positions of systems network in the in a corrosive environment [42], allows to in grease the degree of corrosion. there are many factor used to analyses the corrosion along of piping systems such as ASME B31G [15], B31G [27], DNV-RP F101 [111] which can determine the techniques of safety and efficiency of treat the corrosion problems depending to evaluate the ultimate resistance based on conditions operating. Due to the presence of many kinds of corrosion defects, it can simplify to simple geometry form order to understand including regular or irregular forms such as semi-elliptical, elliptical, rectangular, or square or circle, as shown in Fig.2.4.

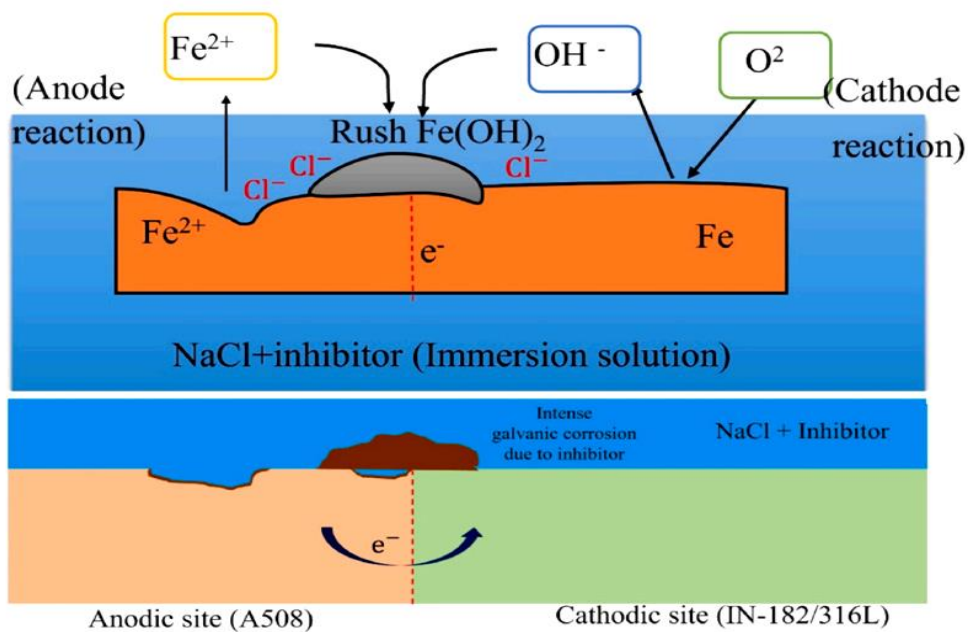
Fig.2.7 Corrosion mechanism on the surface of the DMW [156].

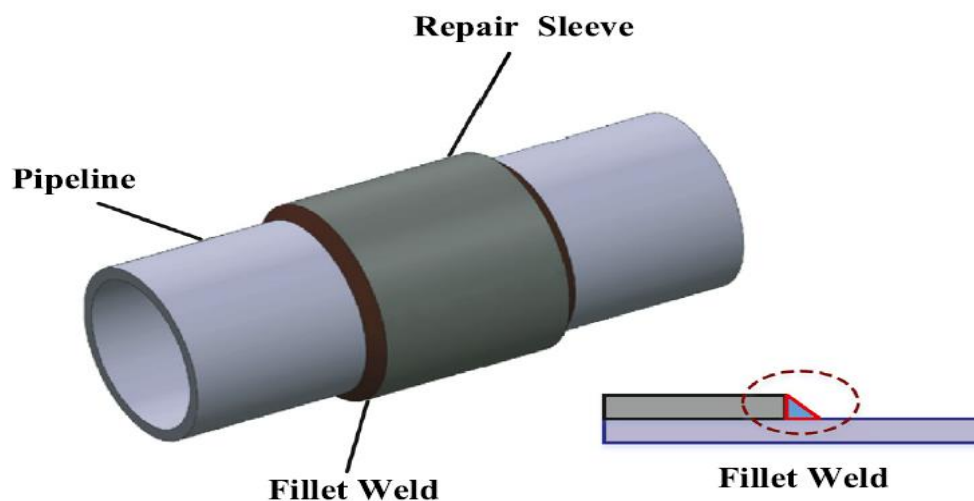
Fig.2.8 Schematic diagram of type-B sleeve repair method for a corroded pipeline [109].

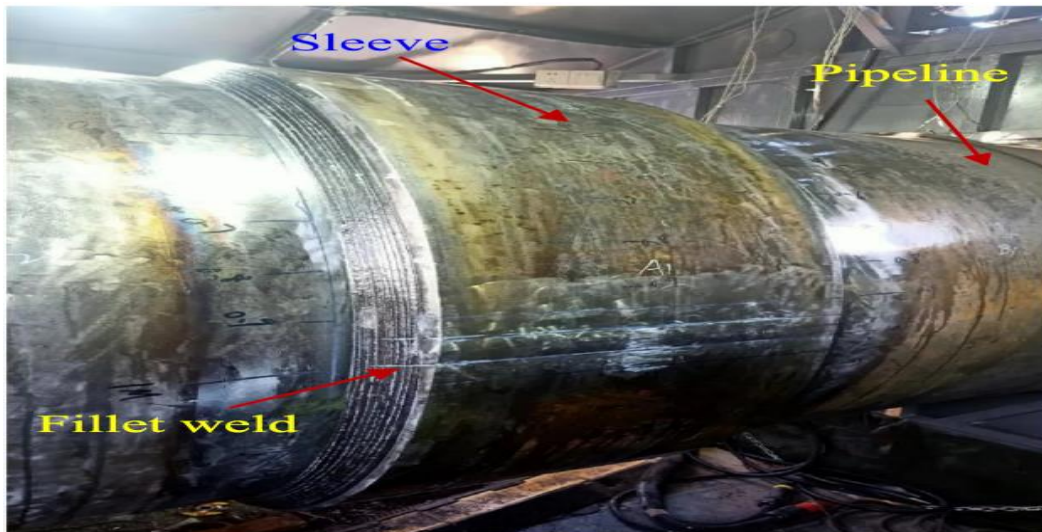
Fig.2.9 Pipeline repair via type B Sleeve [110].

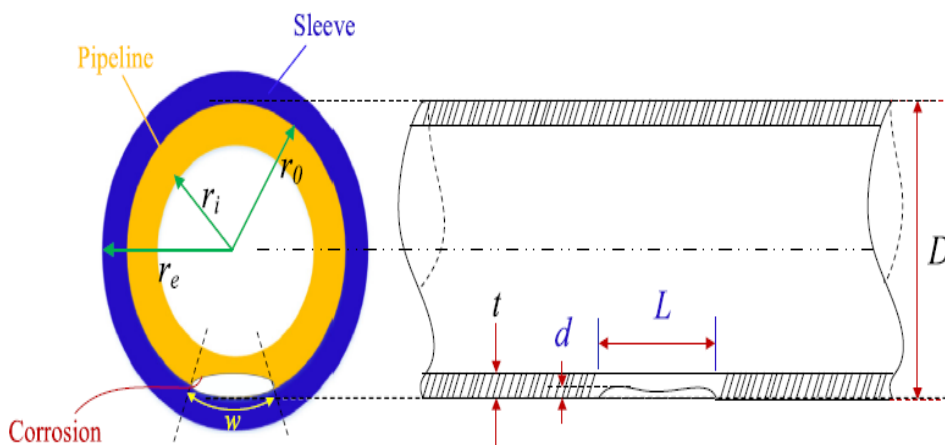
Fig.2.10 Composite structure of corroded pipeline repaired by sleeve [170].

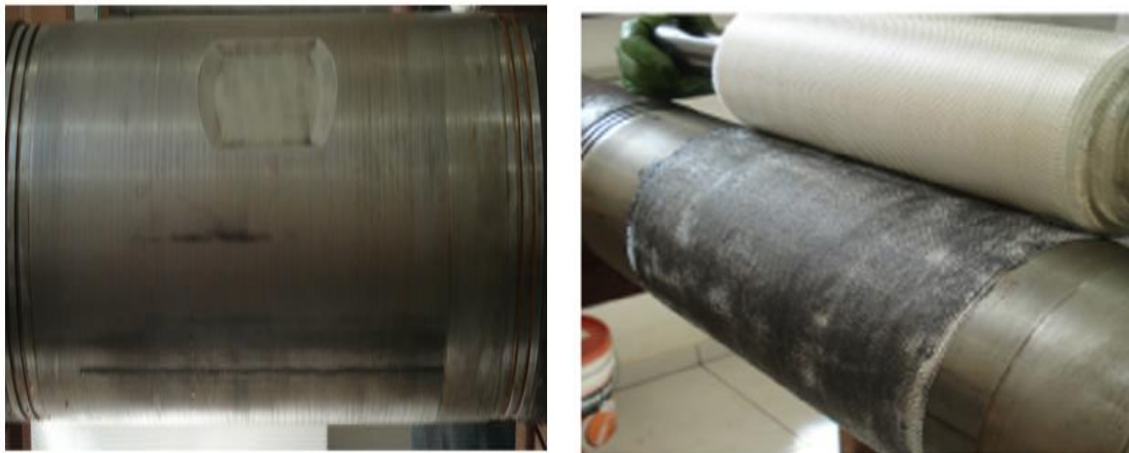
Fig.2.11 Specimen repair preparation of defect for hydrostatic testing [112].

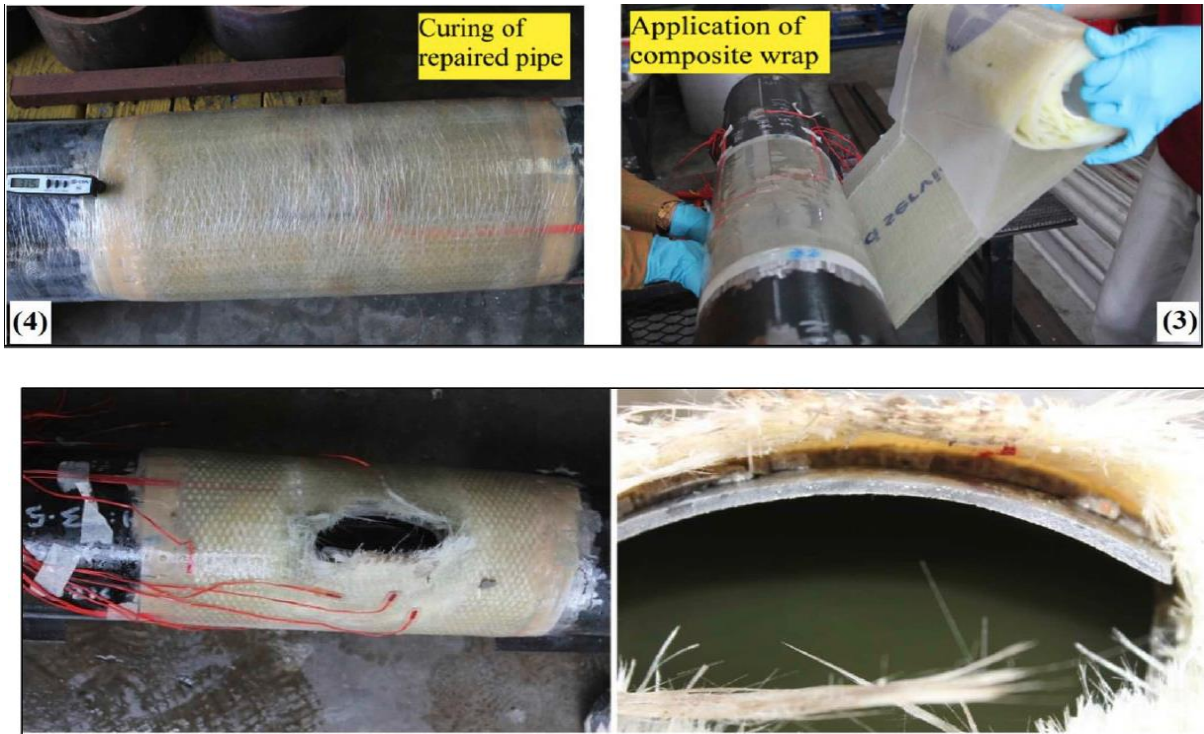
Fig.2.12 Application of composite wrap on the defective pipe [113].

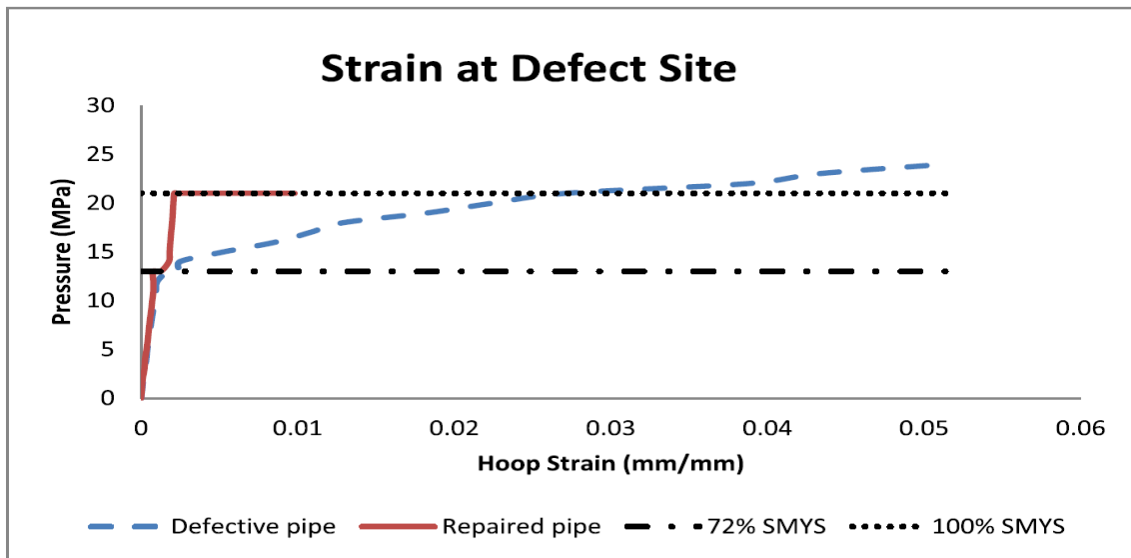
Fig.2.13. Comparison of strains in the defective and repaired pipes [113].

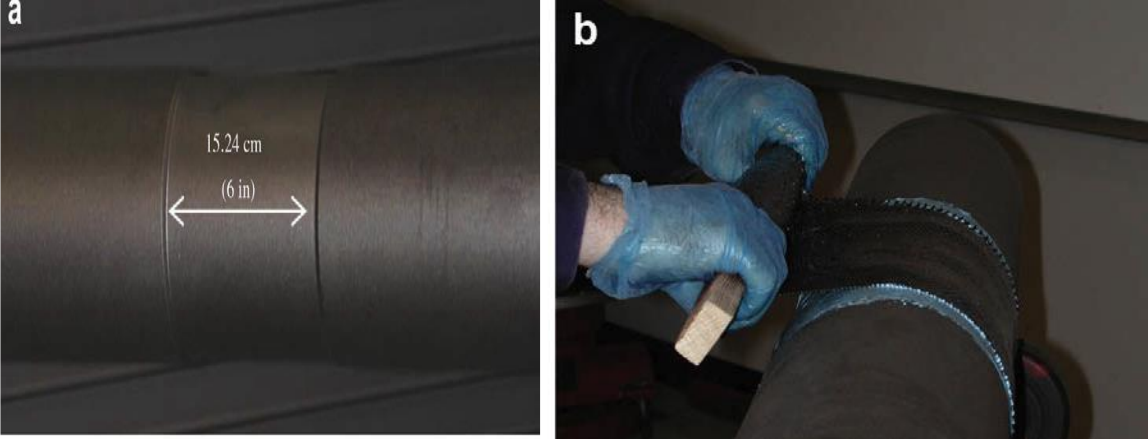
Fig.2.14 Pipe test vessels with machined flaws with a depth of 50% wall thickness for (a) and (b) Pipe repair process filling defect with putty[114].

The creation of defects in piping systems was wrapped with carbon fiber/epoxy which can be reinforced by patch as shown in the Figs.2.14 and 2.15.

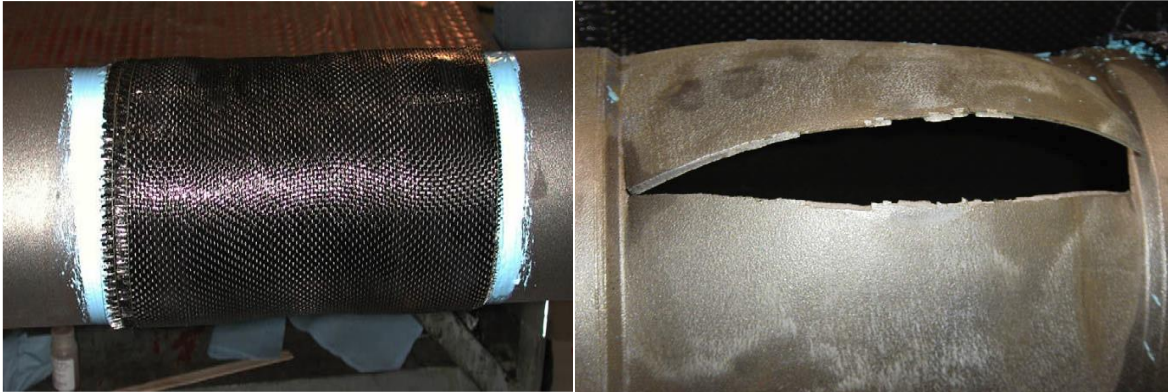
Fig.2.15 Wrapping epoxy wetted carbon fabric around the defecting and b Example of a ruptured vessel with an axisymmetric defect [114].

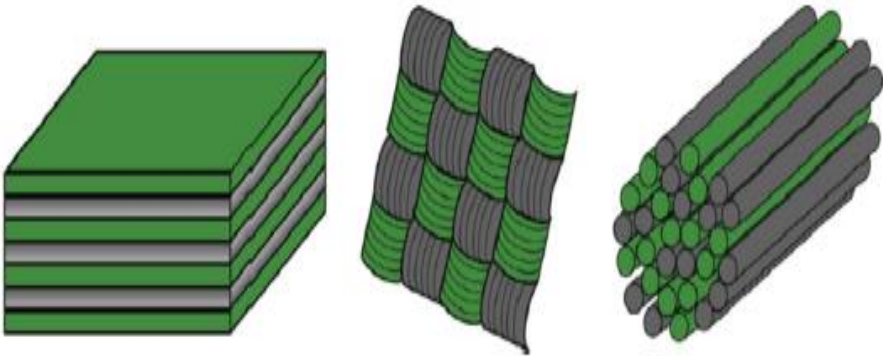
Fig.2. 16 The three main hybrid configuration (a) interlayer or layer by layer,(b)interlayer or yarn-by-yarn, and (c) interlayer or fiber by fiber[ 172-174].

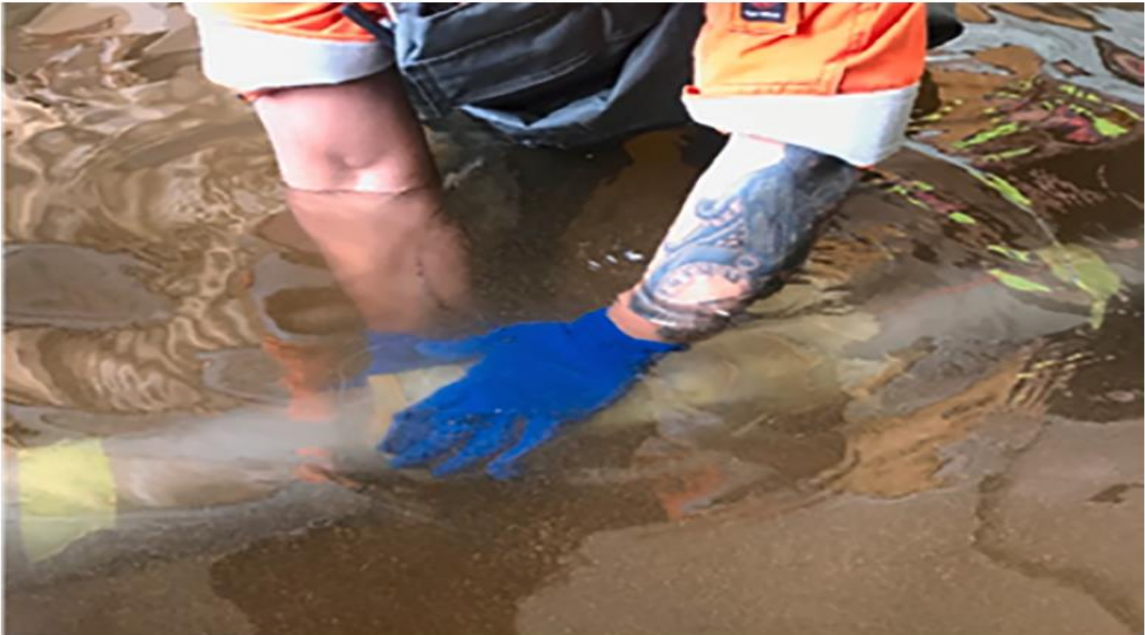
Fig.2. 17 Repairing in water with hybrid glass/carbon layers [175].

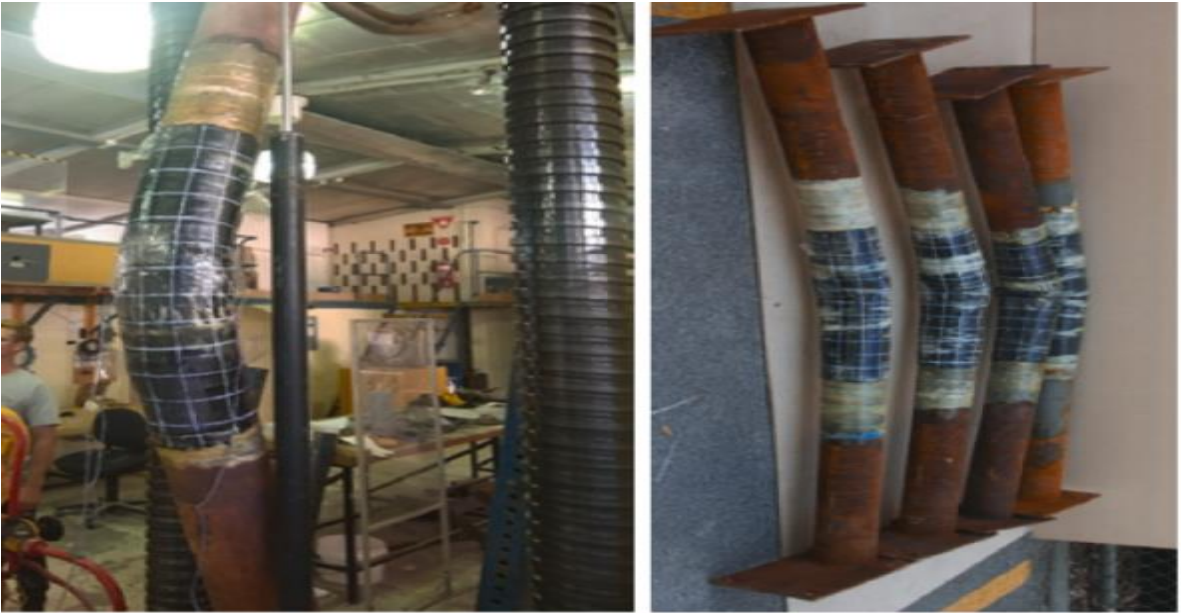
Fig.2.18 Testeafter combined axial compression [175].

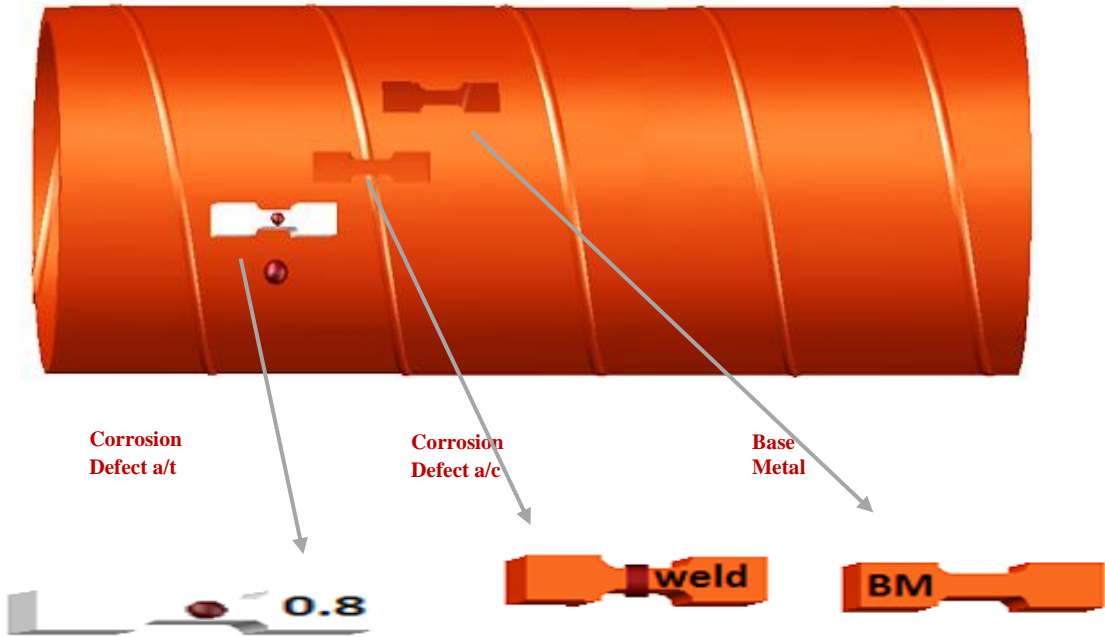
**Fig.3.3: Location of tensile specimens in API 5L X52 pipe.**

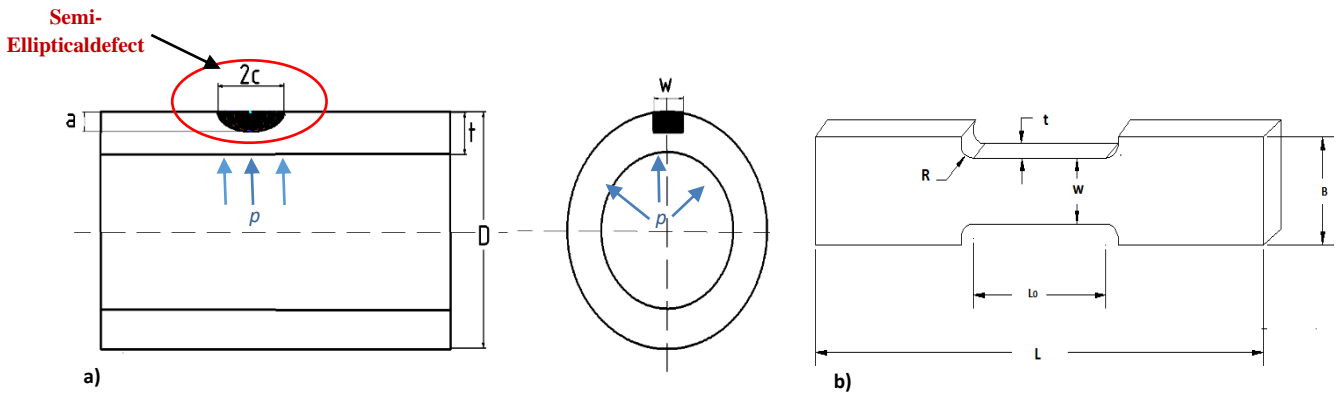
Model of a corroded pipeline (w: corrosion width, c: corrosion length, a: corrosion depth).

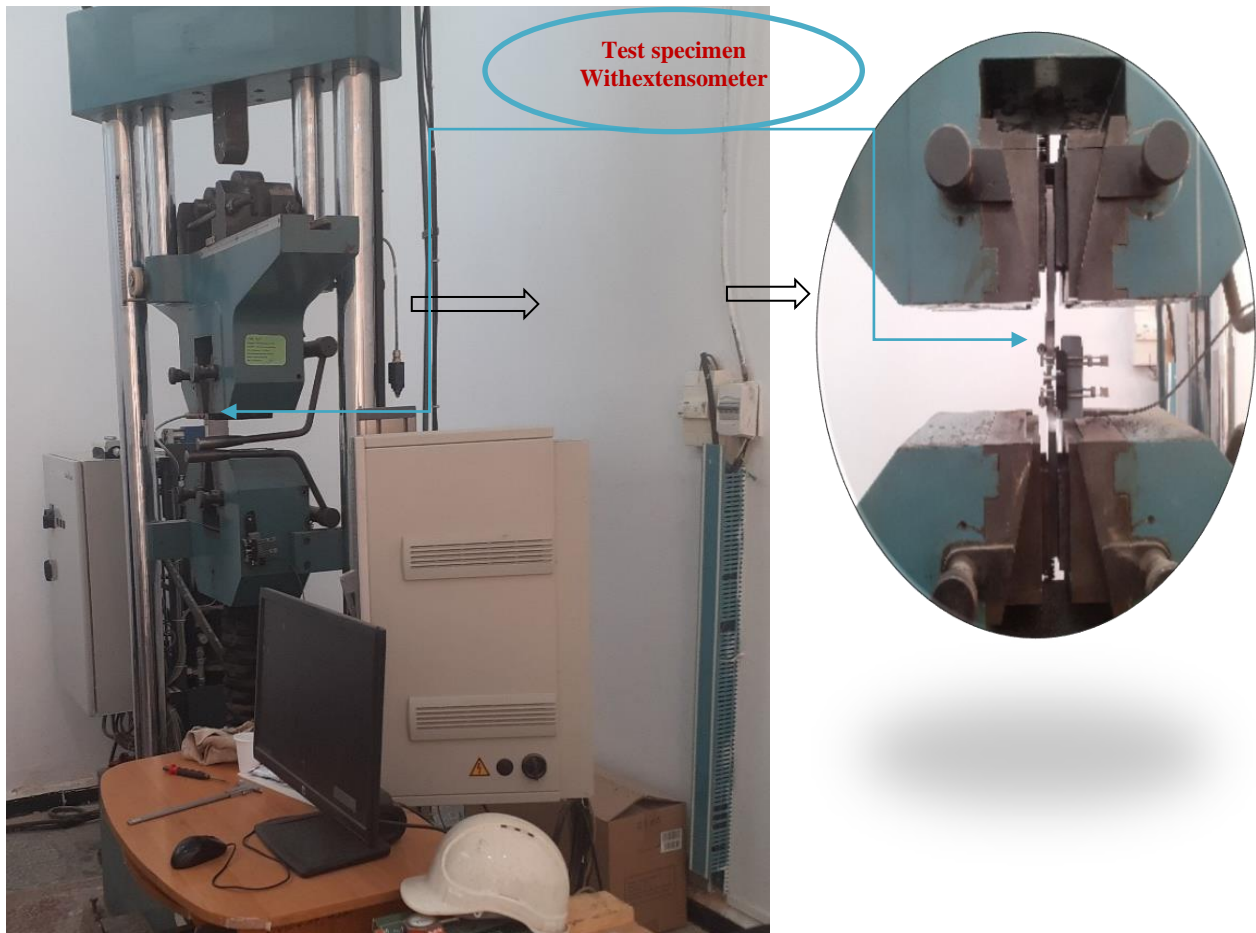
Fig.3.6 a) Zwick-Roell brand universal testing machine, b) Specimen with defect and without defect.
