Hassiba Benbouali University of Chlef

## DOCTORATE

**Investigate of pipelines repair by composite materials and natural fibers, considering the influence of the chemical properties of hydrocarbons on their structures**

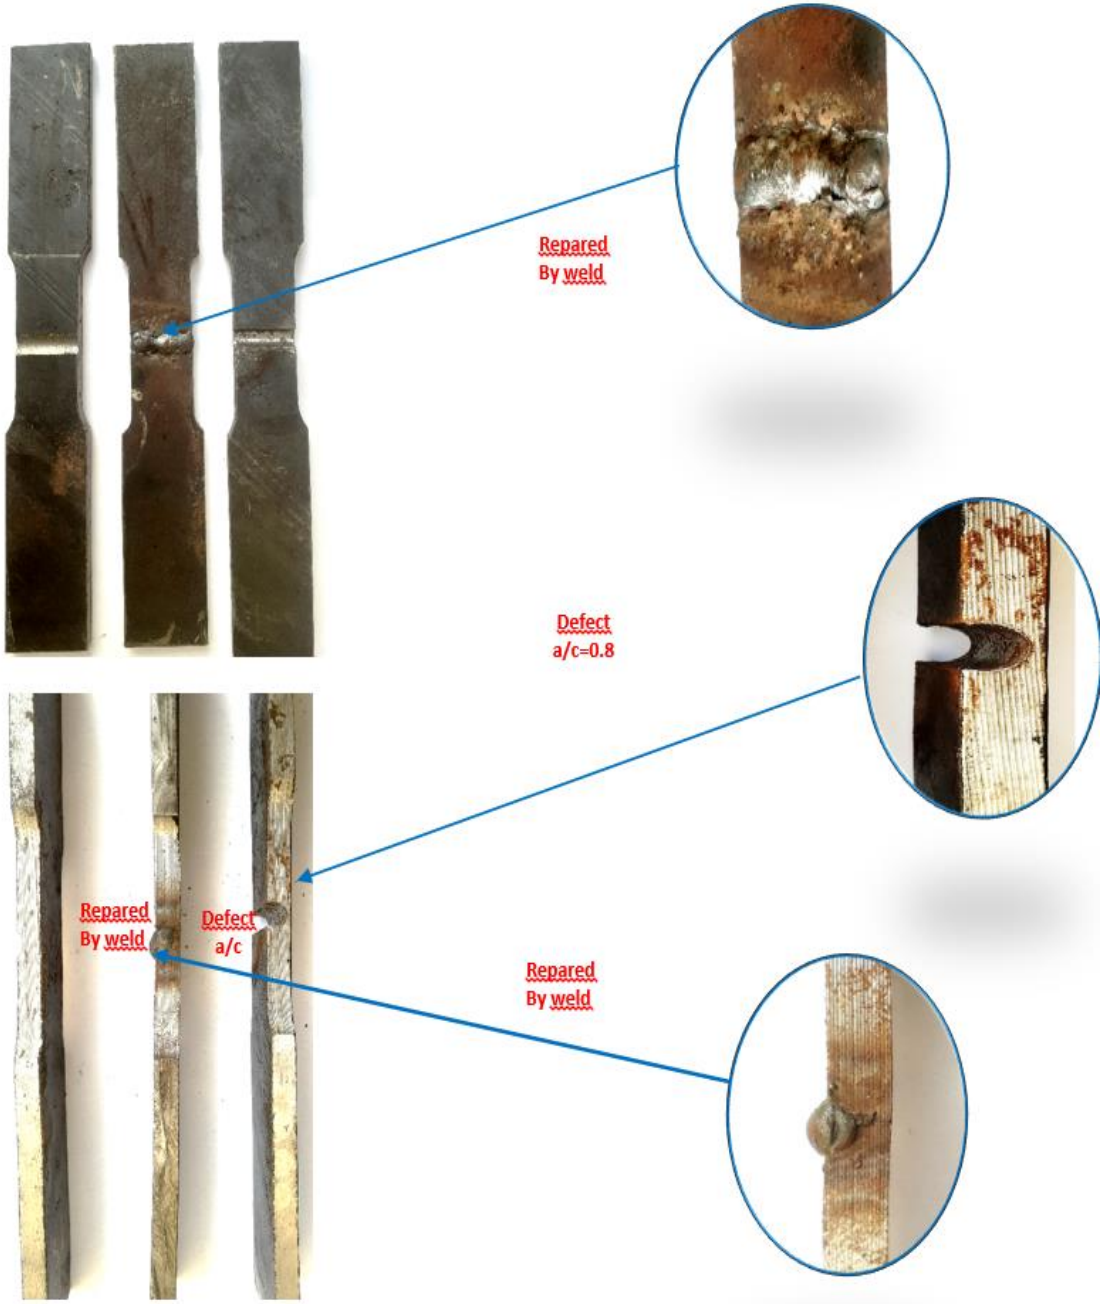
Fig.3.7 Specimen with defect, without defect, and repaired by weld.

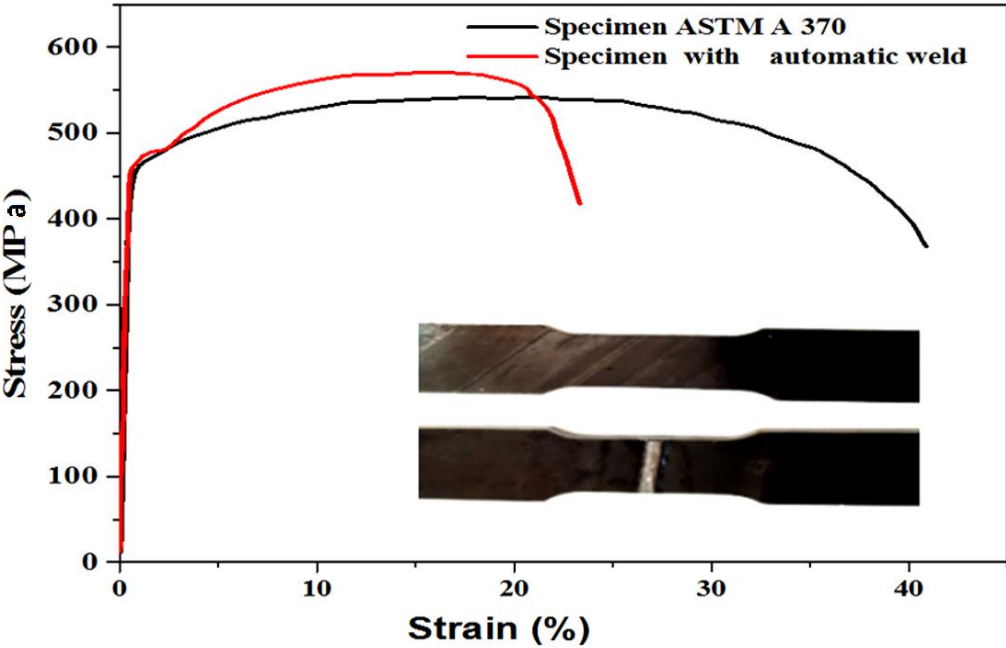
Fig.3.8 Stress-Strain curve for API X 52 pipeline steel when tested with specimen automatic weld and without weld.

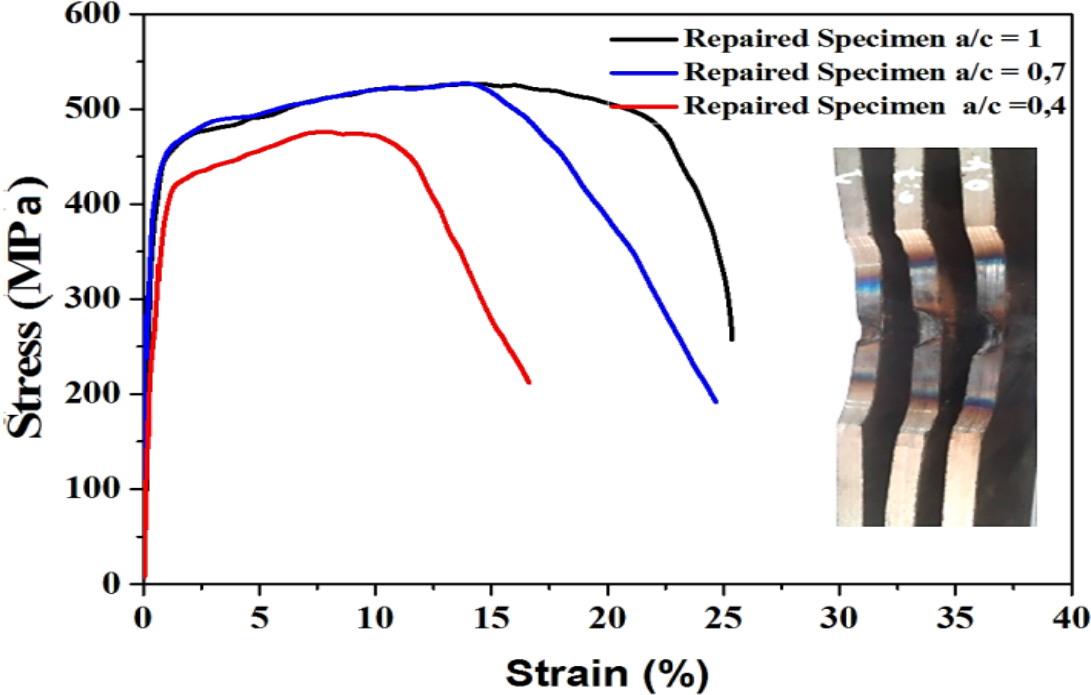
Fig.3.10 Stress-Strain curve for API X 52 pipeline steel when tested with the repaired welding tensile specimens of  $0 < a/c \leq 1$ .

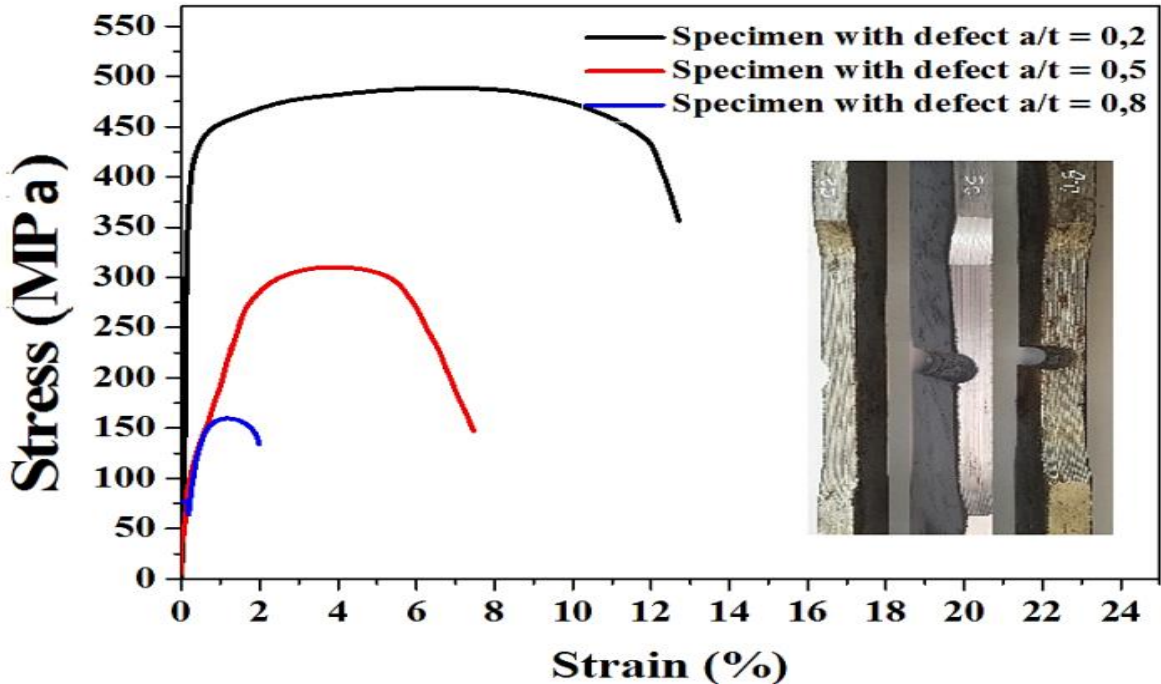
Fig.3.11 Stress-Strain curve for API X 52 pipeline steel when tested with the various defects tensile specimen of  $0 < a/t \leq 0.8$ .

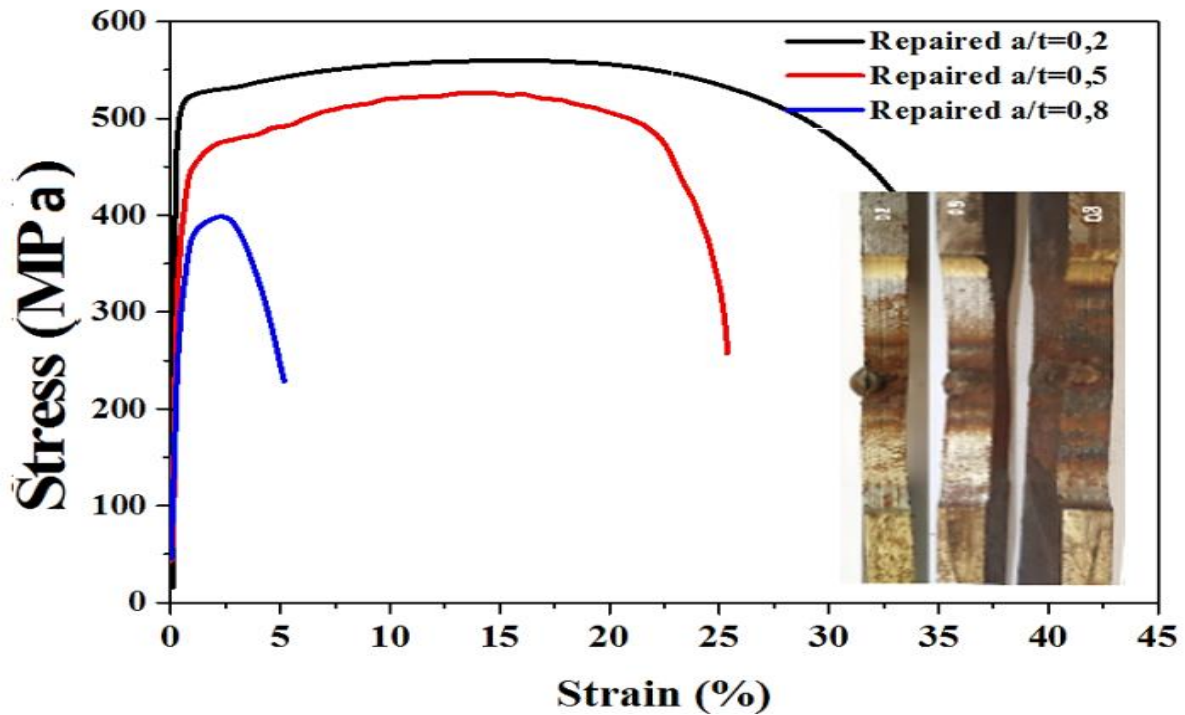
Fig.3.12 Stress-Strain curve for API X 52 pipeline steel when tested with the repaired welding tensile specimen of  $0 < a/t \leq 0.8$ .

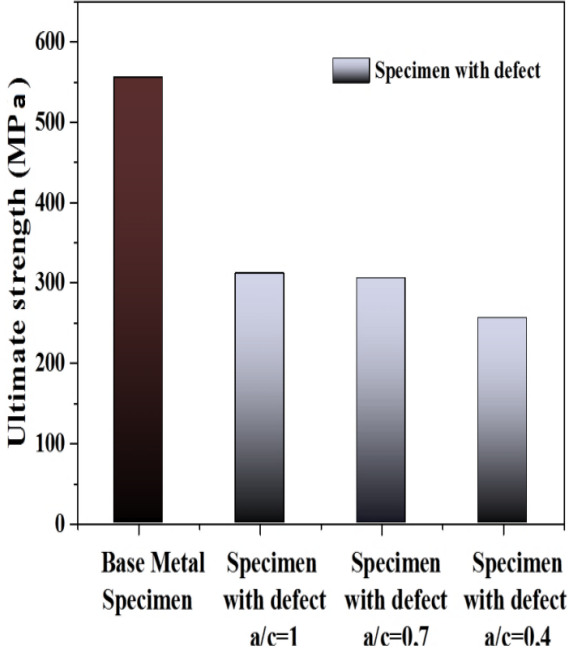
Fig.3.14 Results of ultimate strength when tested with the defect specimens  $0 < a/c \leq 1$ .

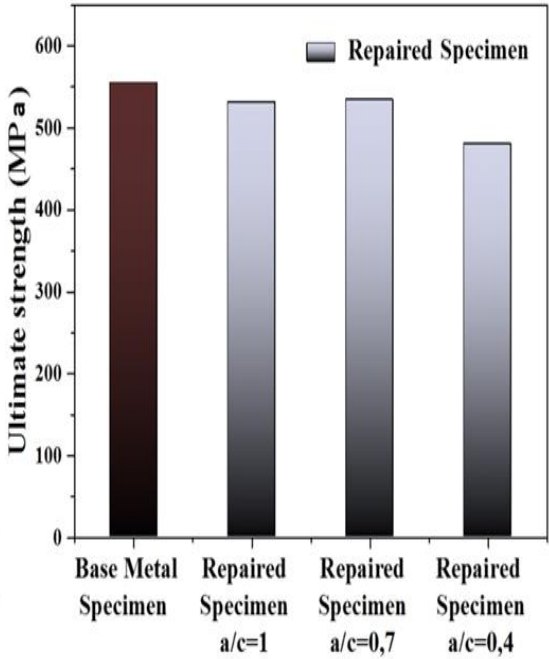
Fig.3.15 Results of ultimate strength when tested with the repaired welding specimens  $0 < a/c \leq 1$ .

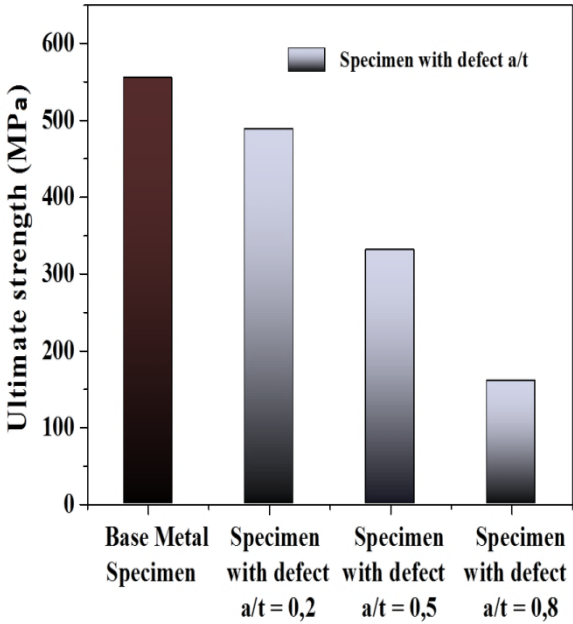
Fig.3.16 Results of Ultimate strength when tested with the defect specimens  $0 < a/t \leq 0.8$ .

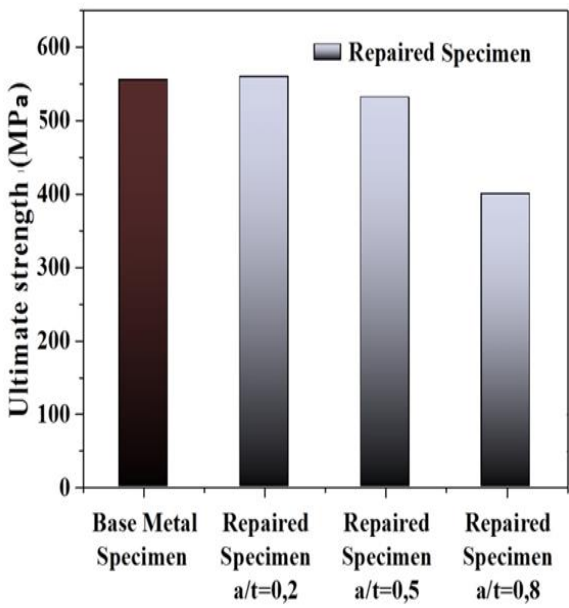
Fig.3.17 Results of Ultimate strength when tested with the repaired welding specimens  $0 < a/t \leq 0.8$ .

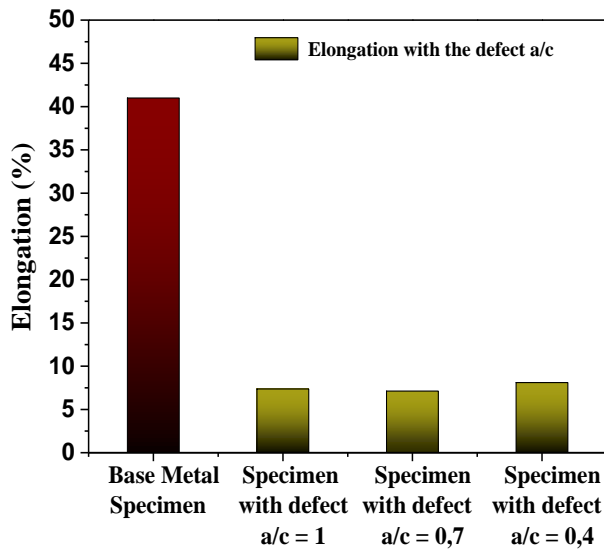
Fig.3.18 Results of elongation in tensile specimen of base metal and with defect specimens of  $0 < a/c \leq 1$ .

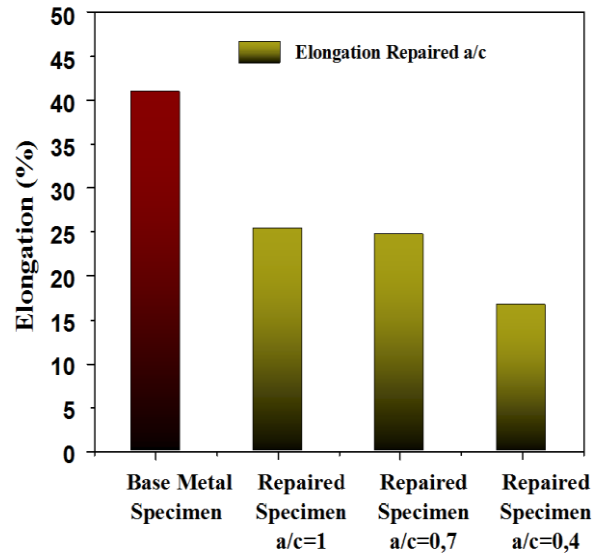
Fig.3.19 Results of elongation in tensile specimen of base metal and repaired welding specimens of  $0 < a/c \leq 1$ .

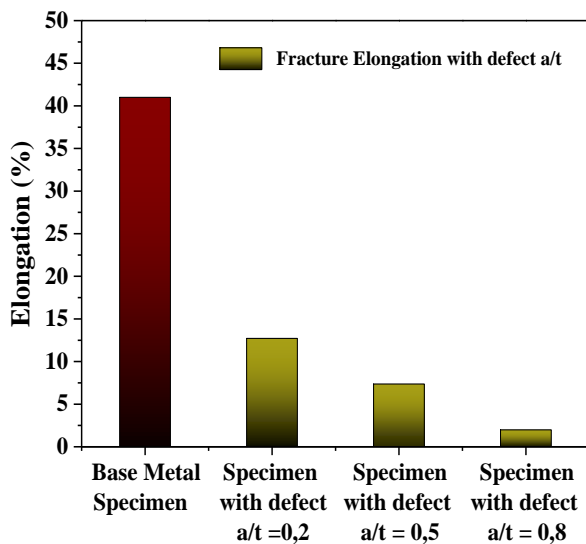
Fig.3.20 Results of elongation in tensile specimen of base metal and with defect specimens of  $0 < a/t \leq 0.8$ .

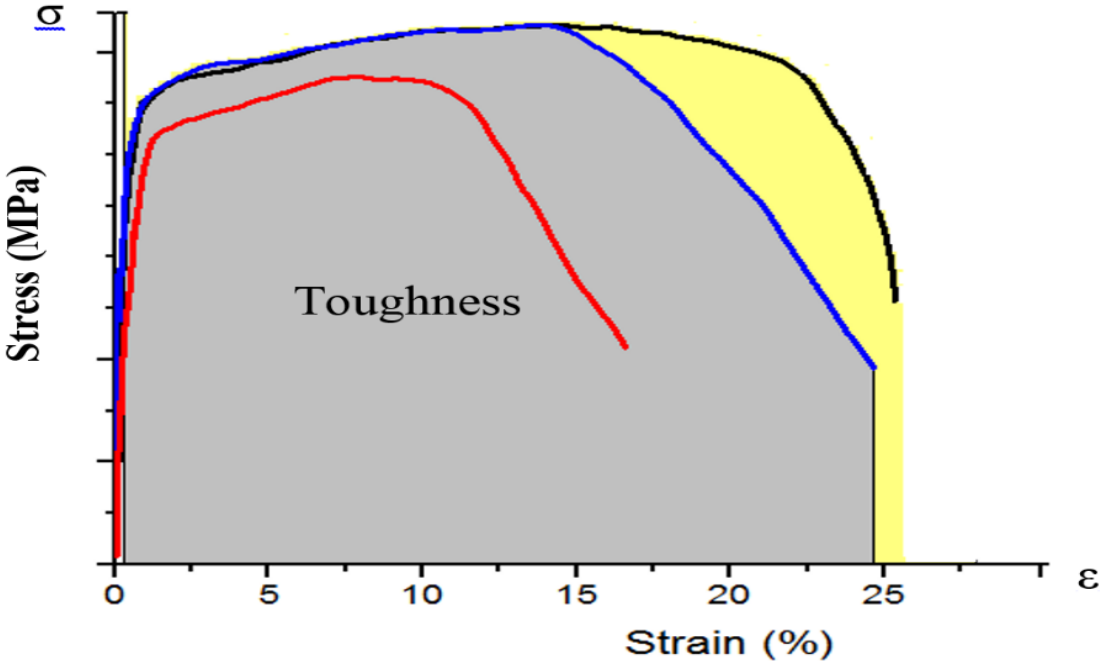
Fig.3.22 Toughness is by calculating the areas under the stress-strain curves.

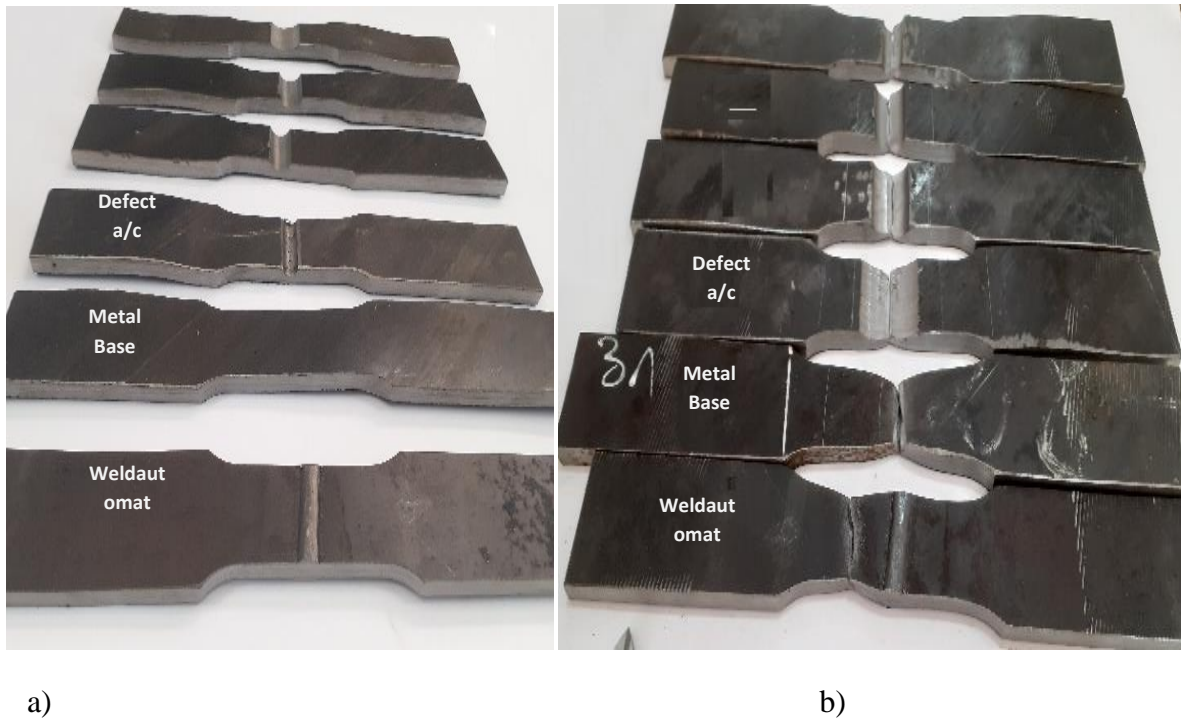
Fig.3.23 Experimental set up (a) Before Failure, (b) After Failure.

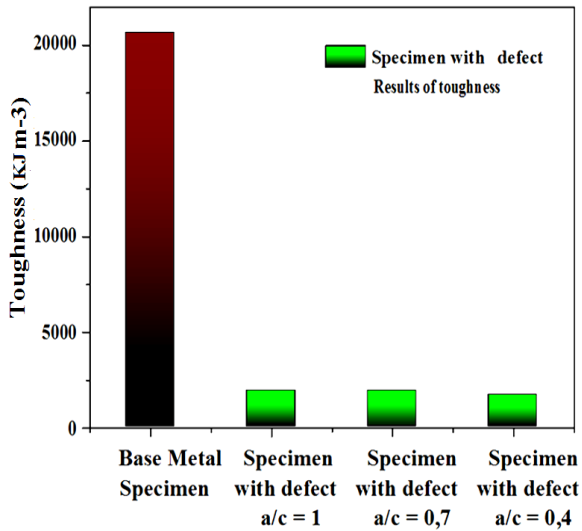
Fig.3.24 Results of toughness in tensile specimen of base metal and with the defect specimens of  $0 < a/c \leq 1$

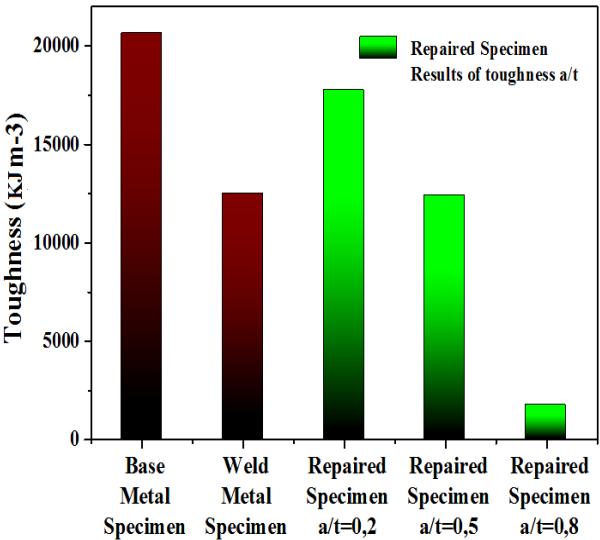
Fig.3.27 Results of toughness in tensile specimen of base metal, weld metal sp. and repaired welding specimens of  $0 < a/t < 0.8$ .

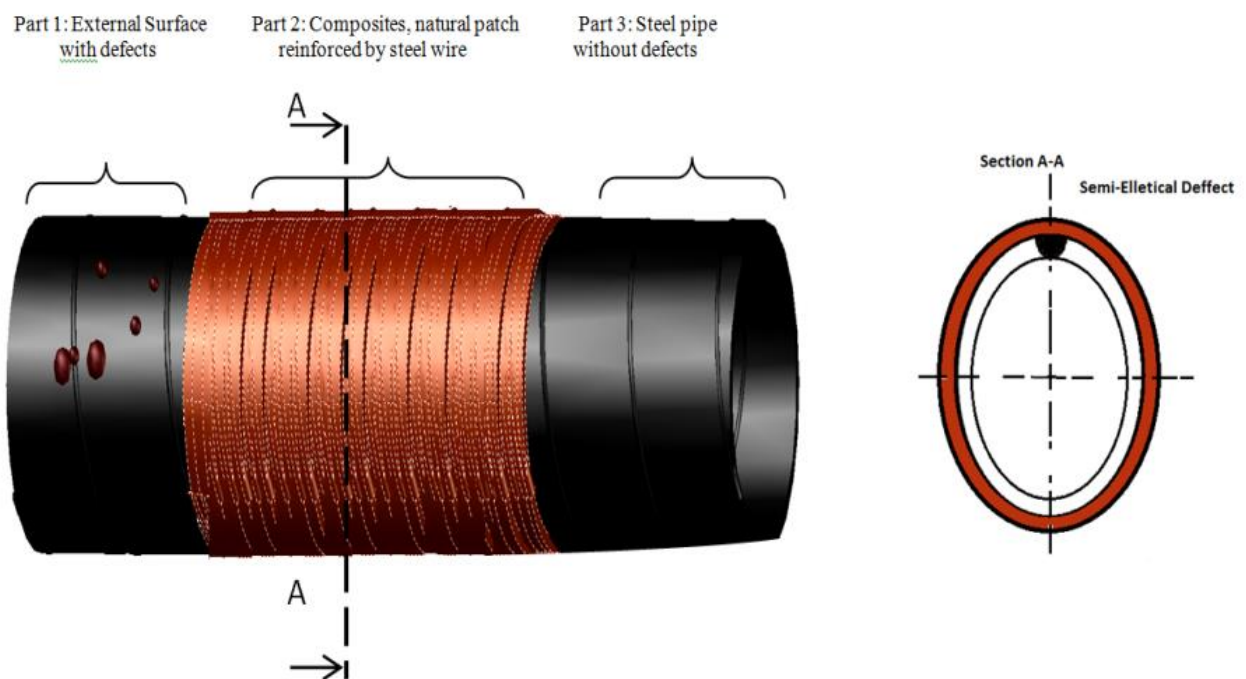
Fig.4.1 The sketch corroded pipeline repaired by hybrid composites (natural fiber and synthetic fiber).

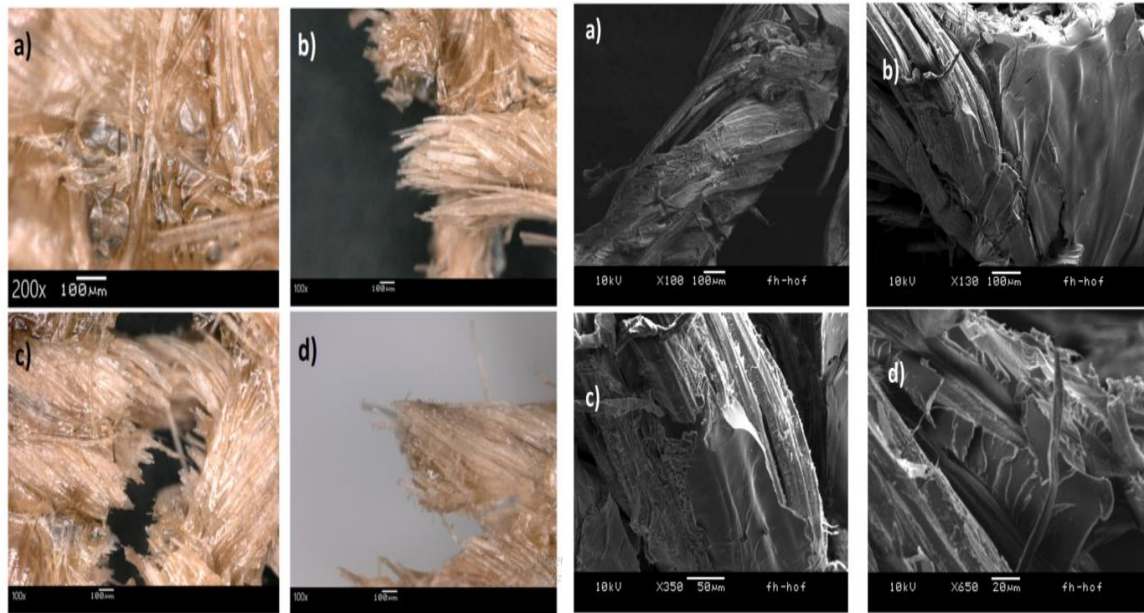
Fig.4.2 Optical images of characteristic locations. a) To d) SEM images of characteristic locations [191].

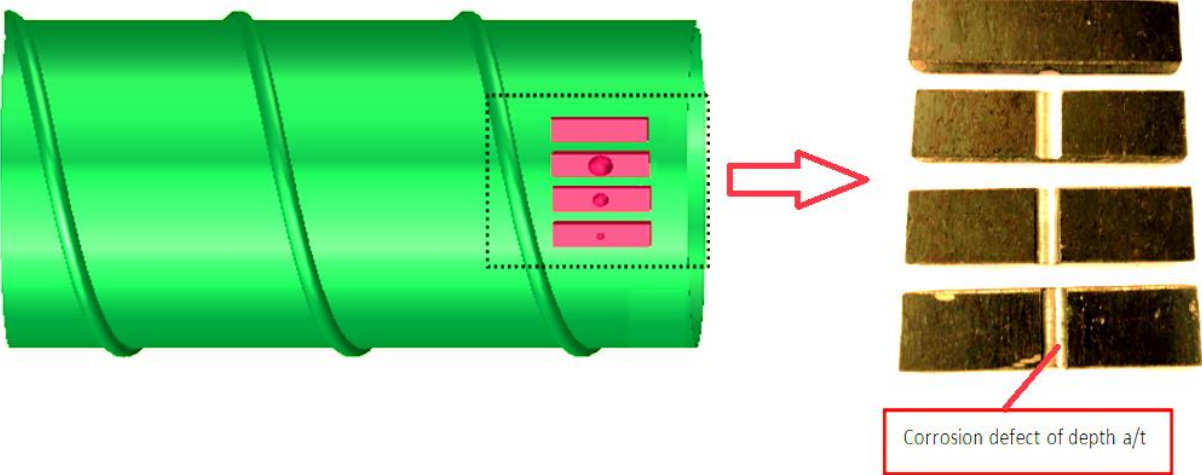
Fig.4.8 Location of bending specimen in API 5L X52 pipe with/without defect.

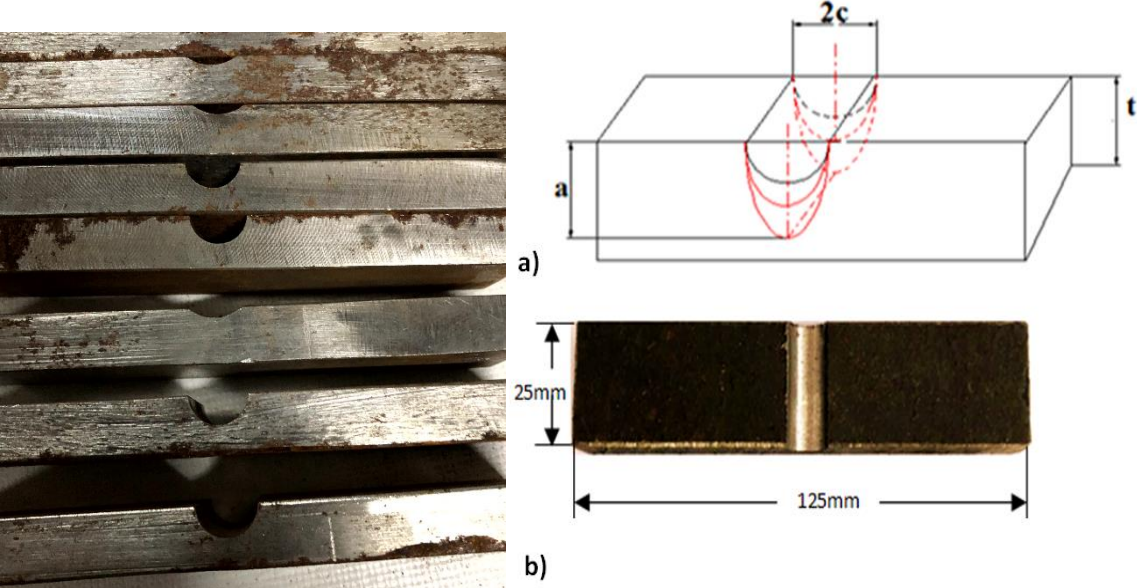
Fig.4.9 a) Geometry standard of semi-elliptical defects, b) Dimension of the test specimen.

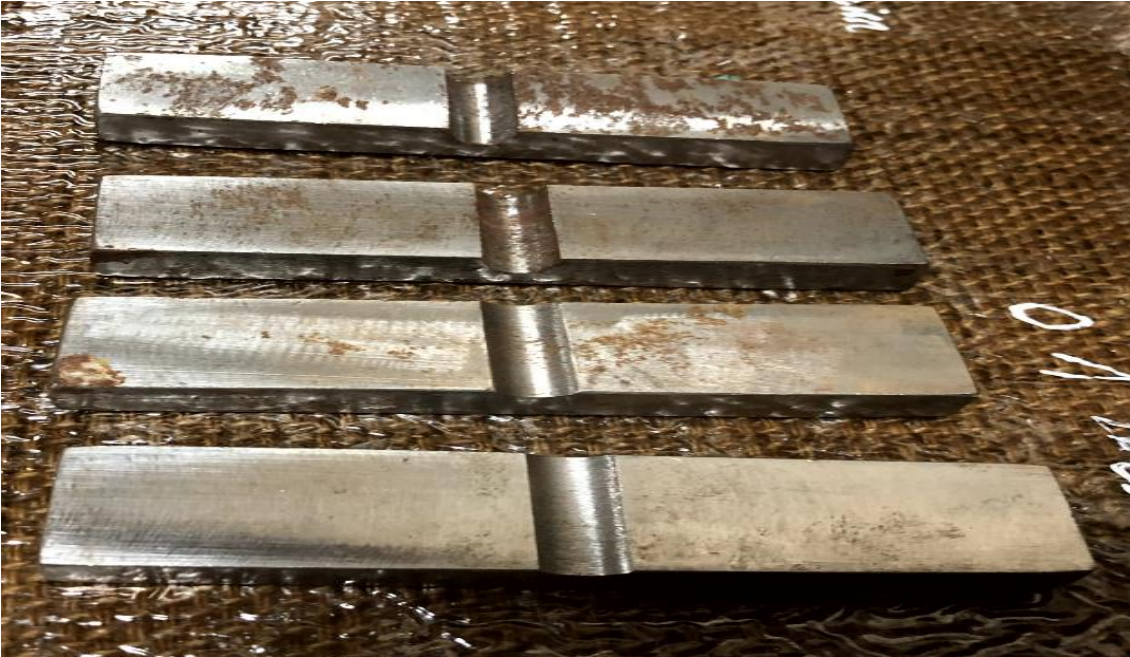
Fig.4.10 Geometry standard of semi-elliptical defects top view.

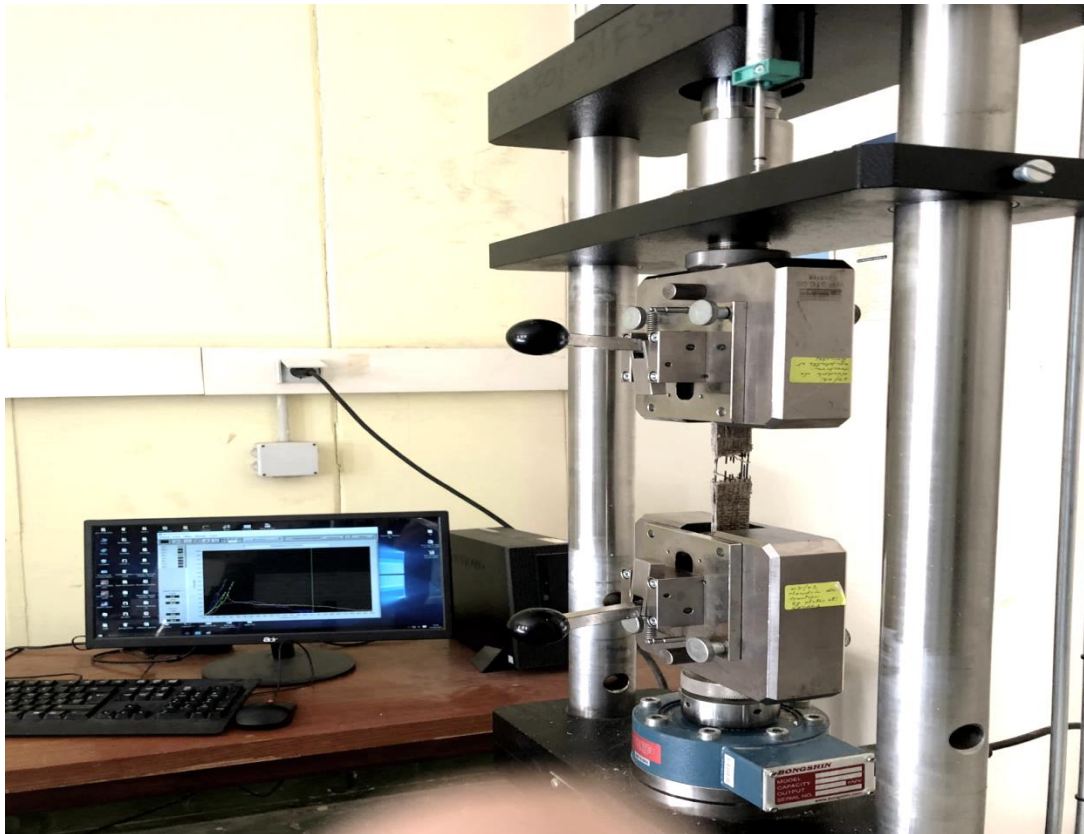
Fig.4.11 Test of the composite specimen (S5) on a universal machine capacity of 50kN.

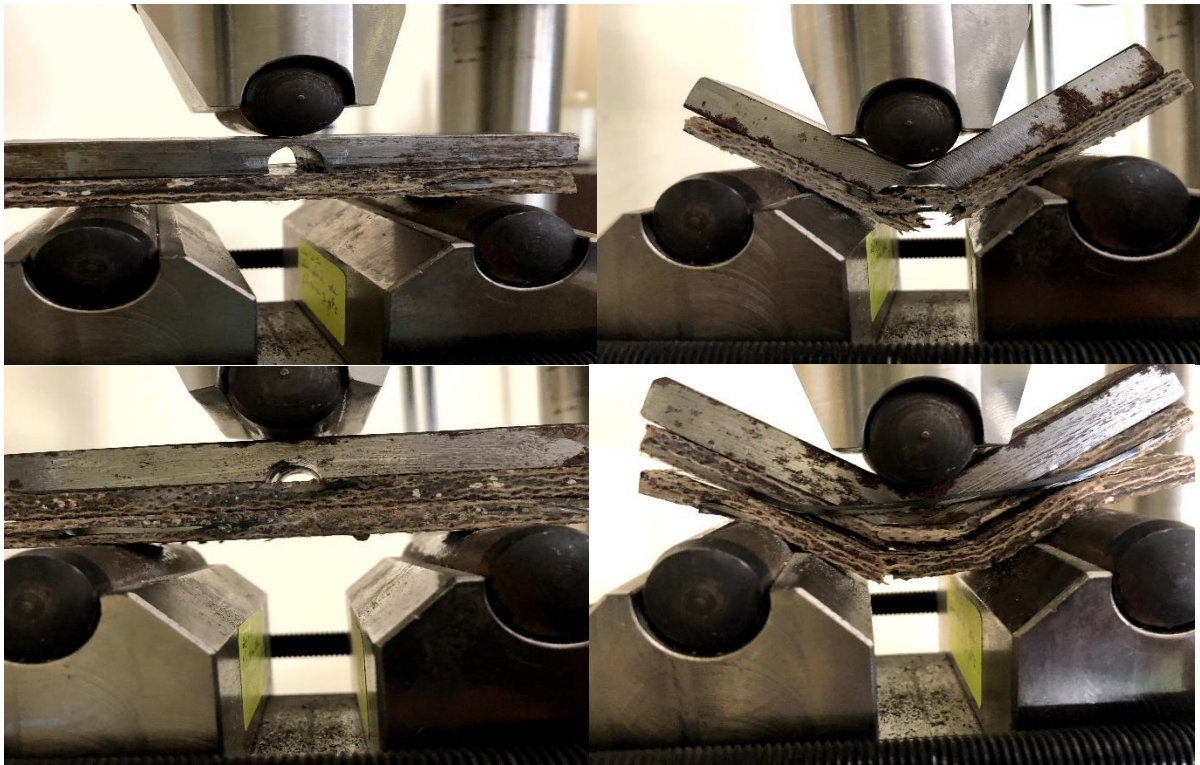
Fig.4.12 Equipment of flexural Testing and defect specimen with patch.

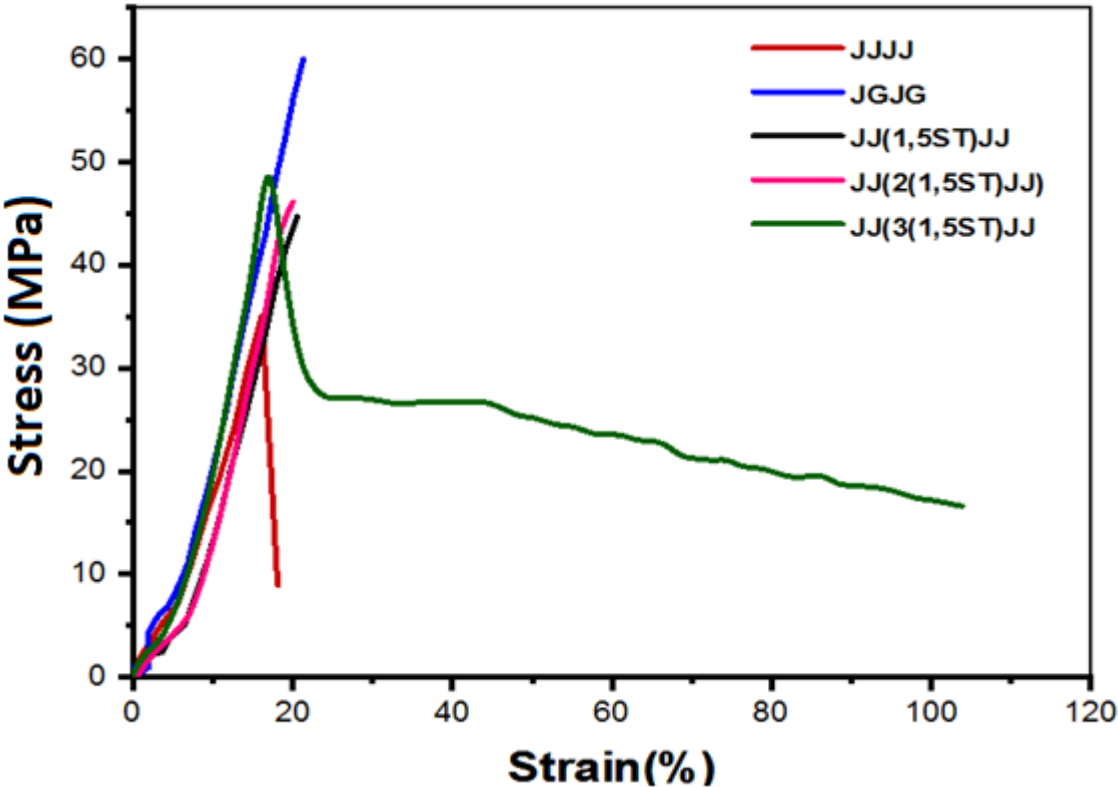
Fig.4.13 Tensile test stress-strain curve of different composite hybrid Jute-Steel wire

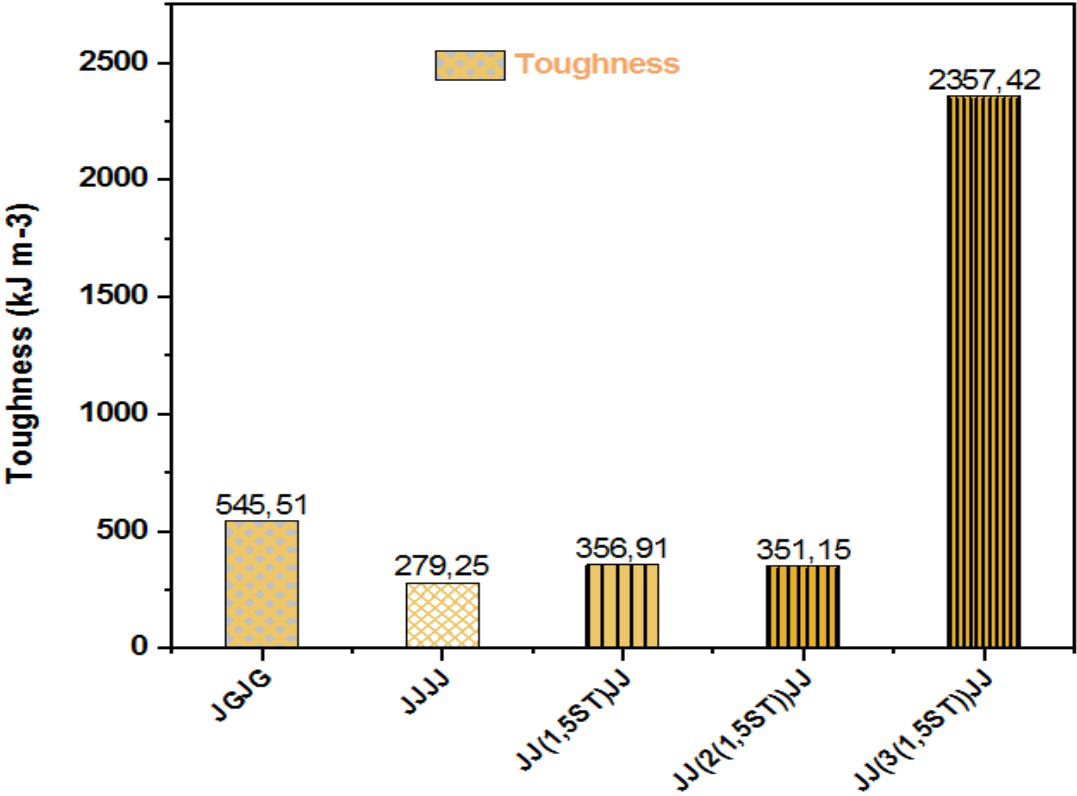
Fig.4.17 Results of toughness in tensile specimen of composite laminates.

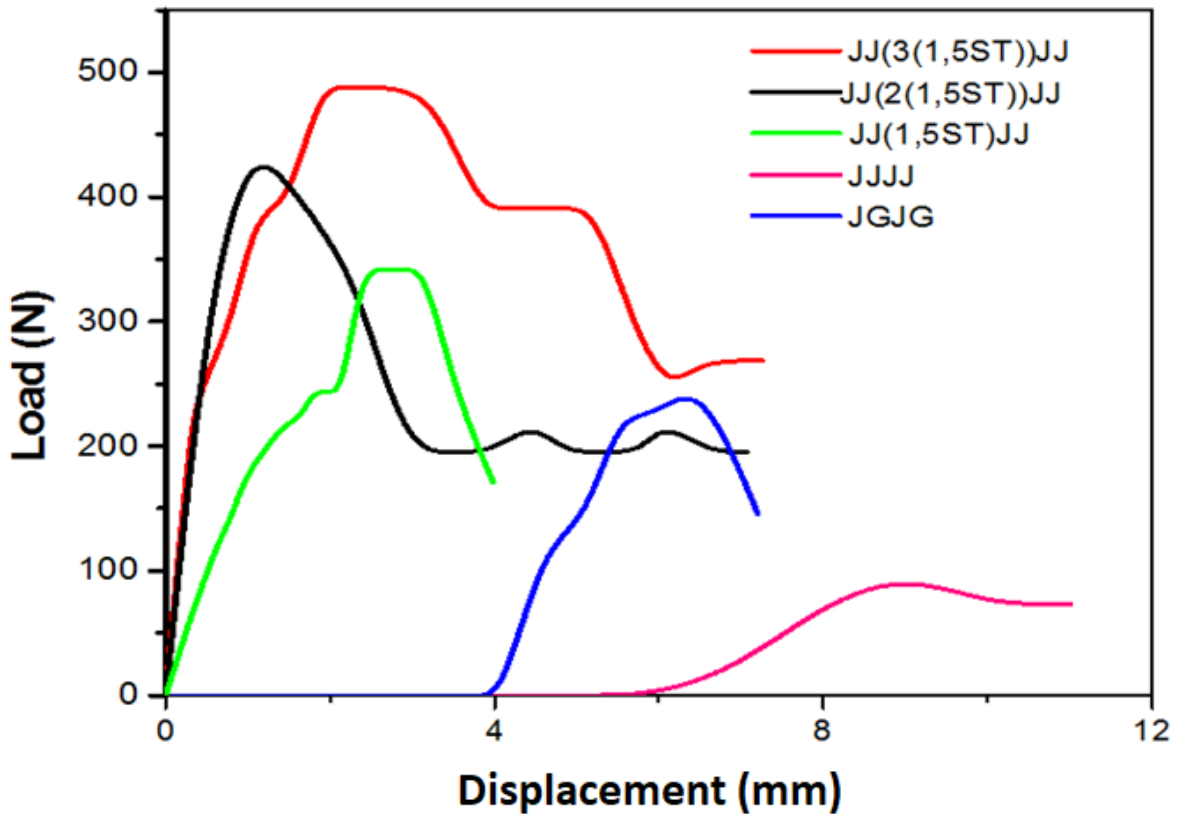
Fig.4.18 Test flexural load-displacement curve of the composite laminates.

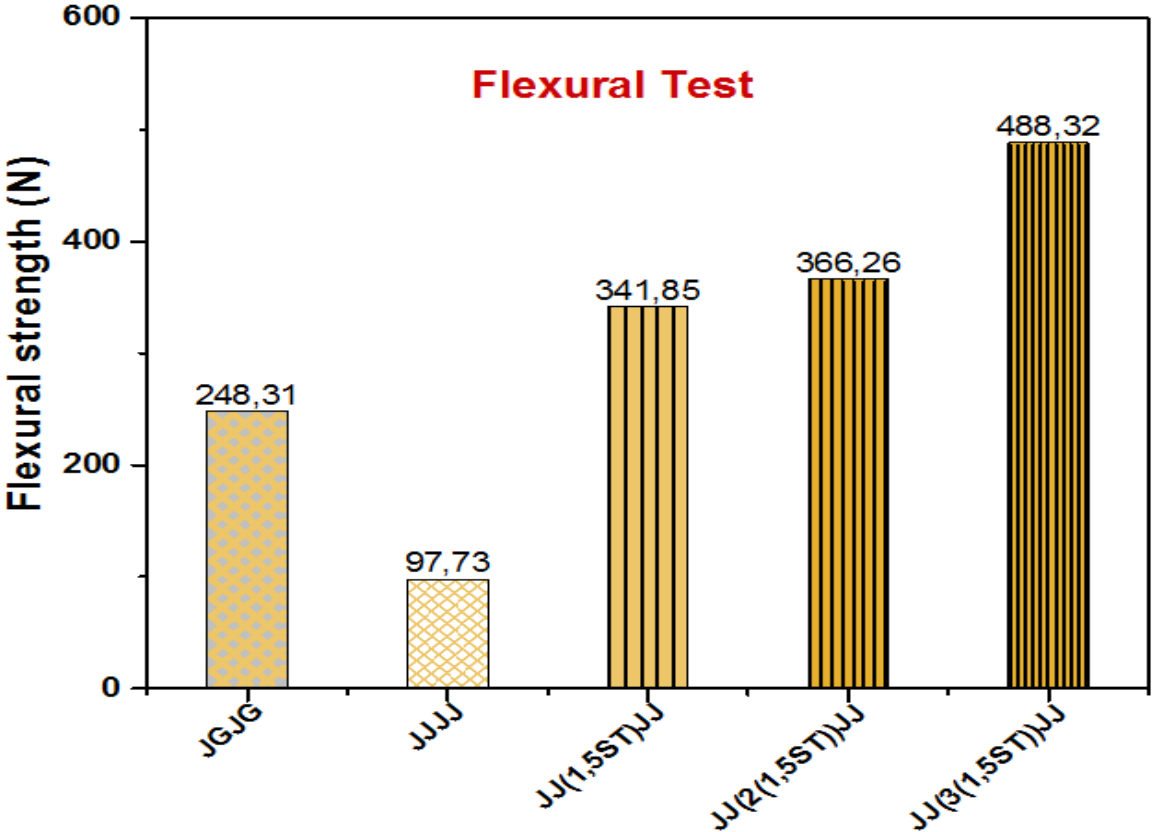
Fig.4.19 Comparison of flexural strength of the composite laminates.

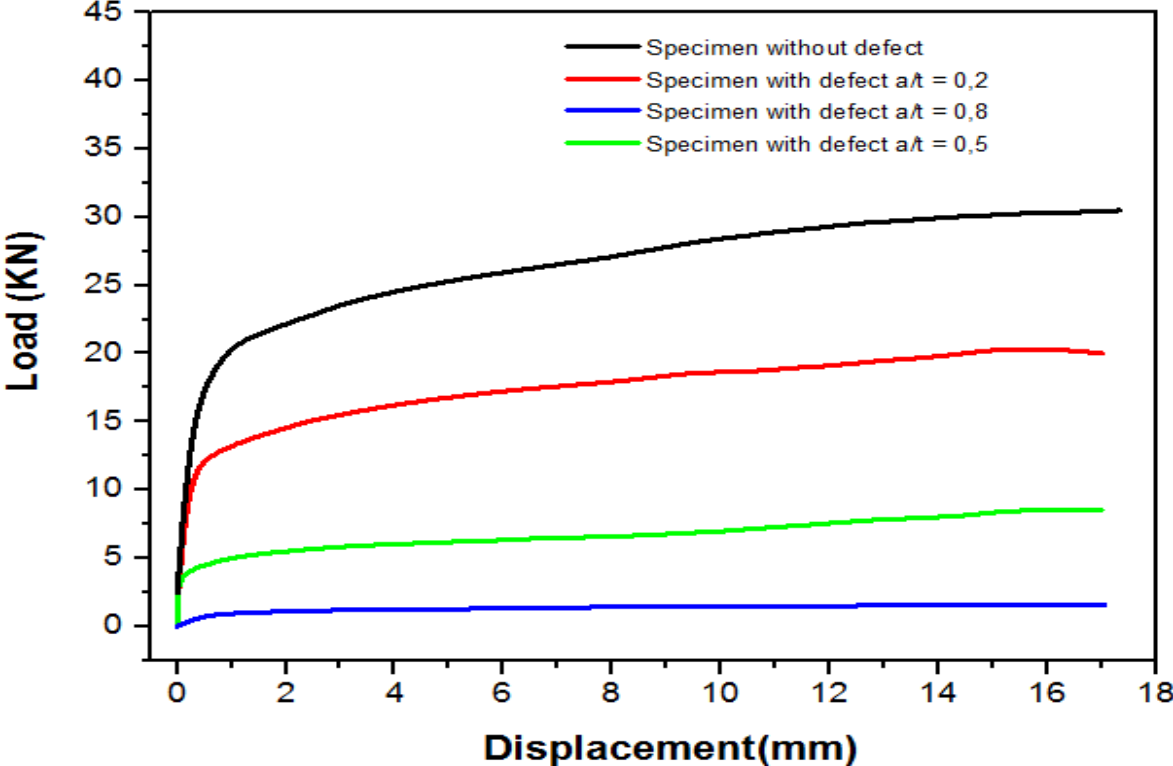
Fig.4.20 Load–displacement curve for API X 52 pipeline defected for various ratios of  $a/t$  ( $0 < a/t \leq 0,8$ ).

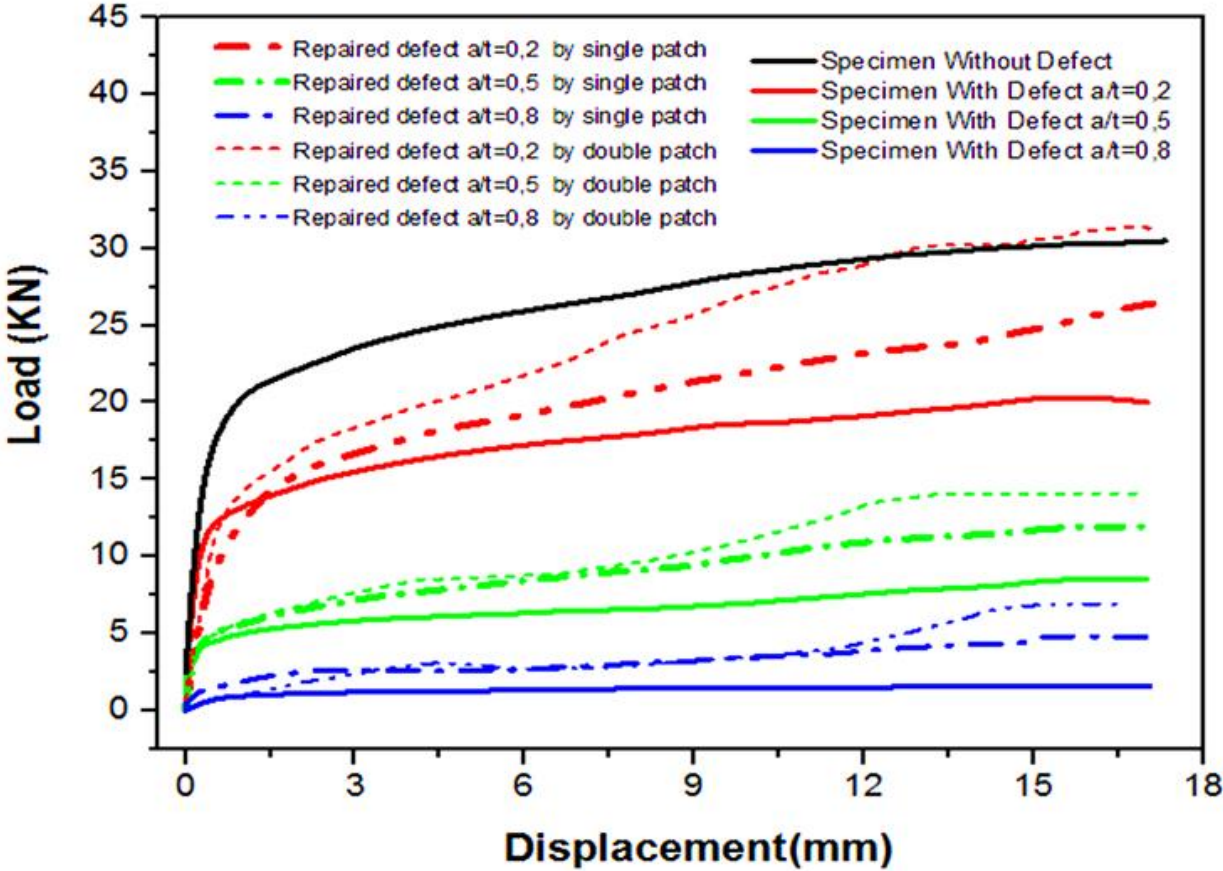
Fig.4.21 Load–displacement curve for API X 52 pipeline steel repaired using the patch composite natural

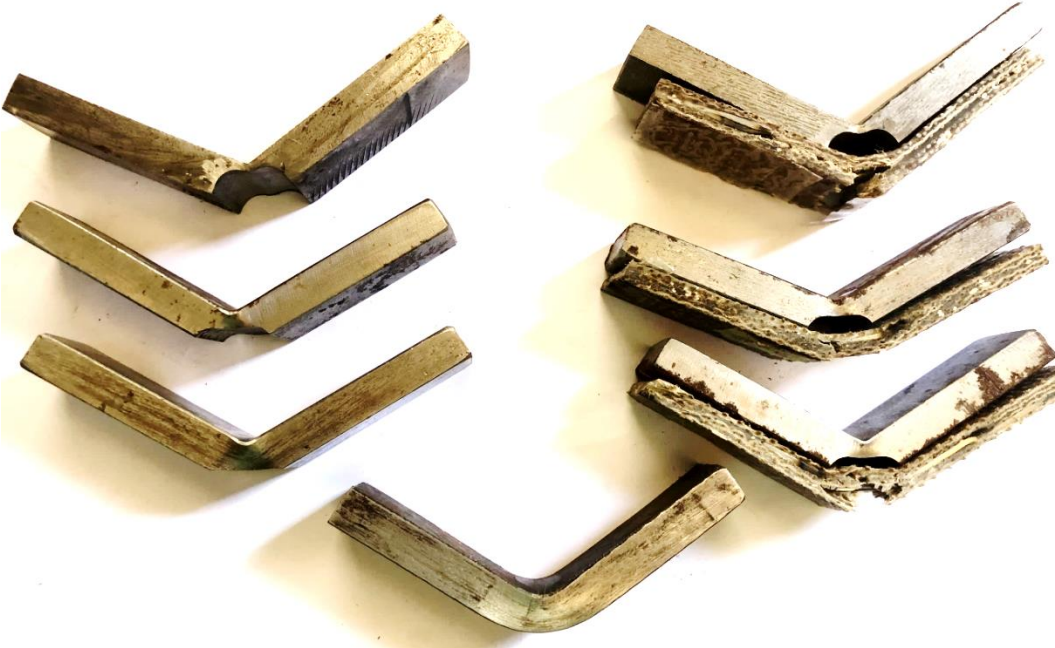
Fig.4.22 Specimen API X 52 pipeline steel test with and without repaired using the patch composite natural.

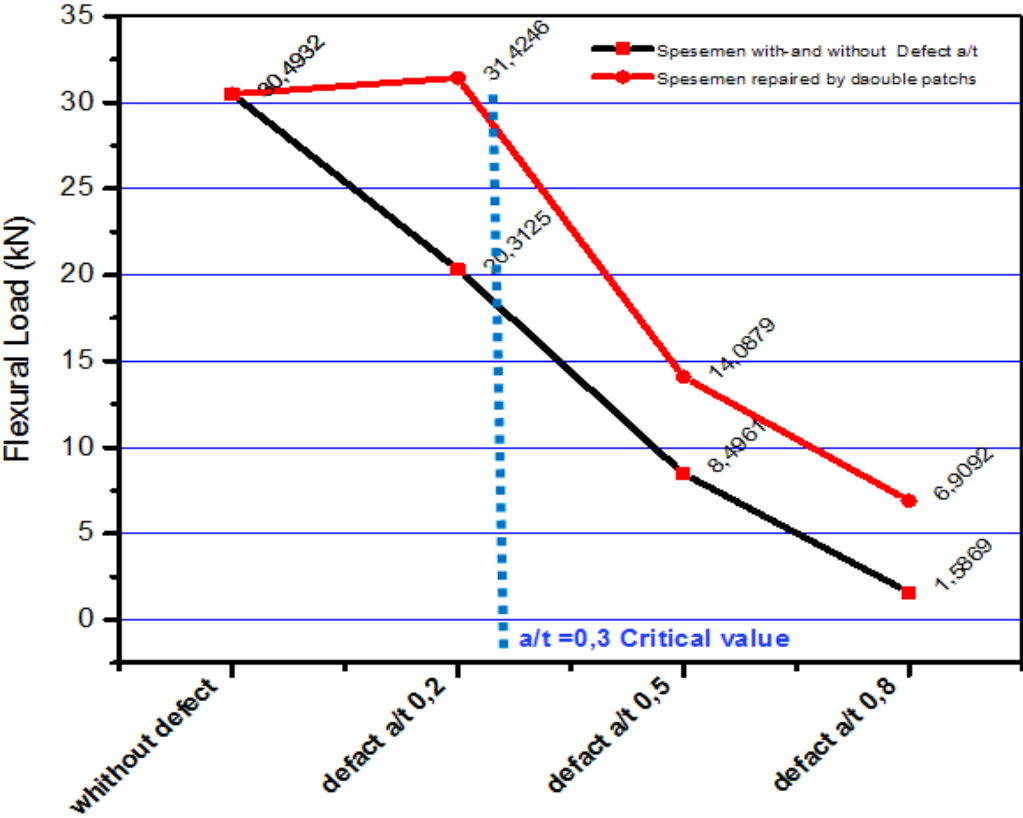
Fig.4.23 Flexural load versus state of specimens of API X 52 pipeline steel: specimens without defects and defected specimens with/without repaired.
