Hassiba Benbouali University of Chlef

## DOCTORATE

**Investigate of pipelines repair by composite materials and natural fibers, considering the influence of the chemical properties of hydrocarbons on their structures**

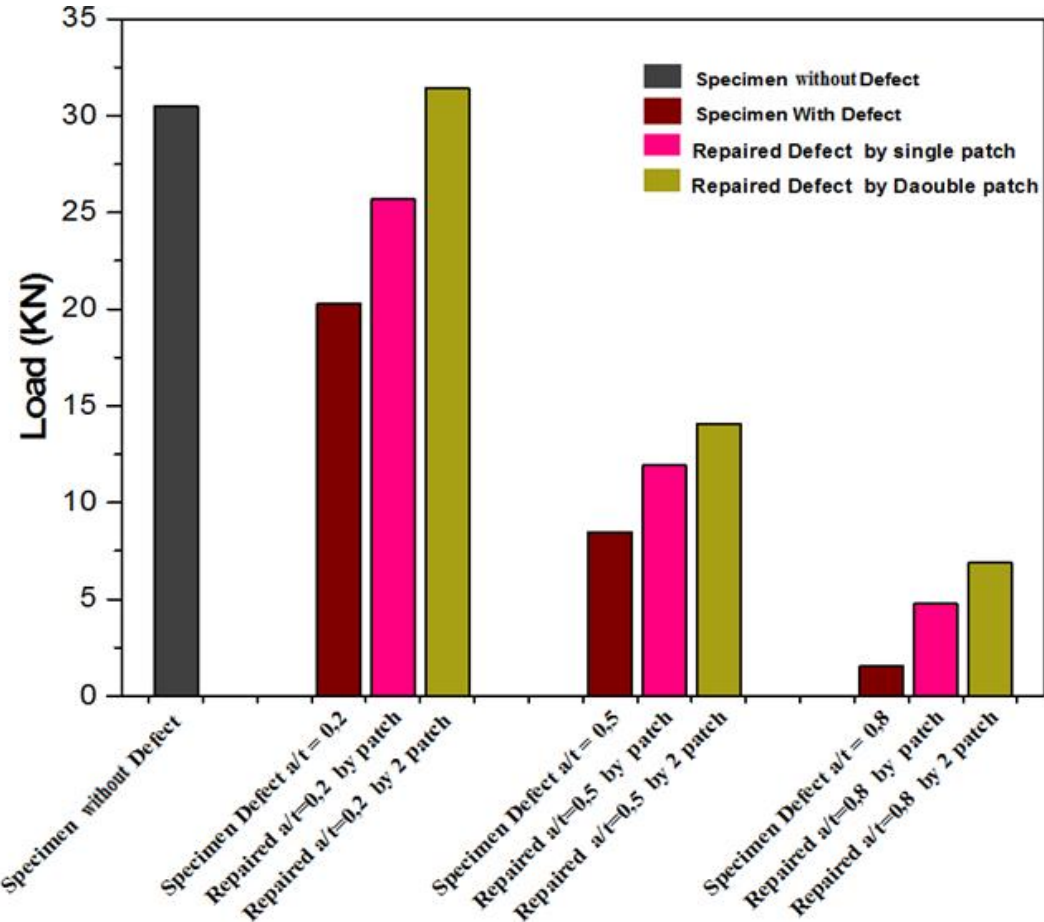
Fig.4.24 Comparison of ultimate load of API X52 pipeline steel between specimen without defect and specimens with defect for different ratios ( a/t ) which were repaired using composite of natural hybrid (S5).
